Service Life of Two 100 Year Old Concrete Bridges in Latvia

Kristaps Gode, *Riga Technical University*, Ainars Paeglitis, *Riga Technical University*

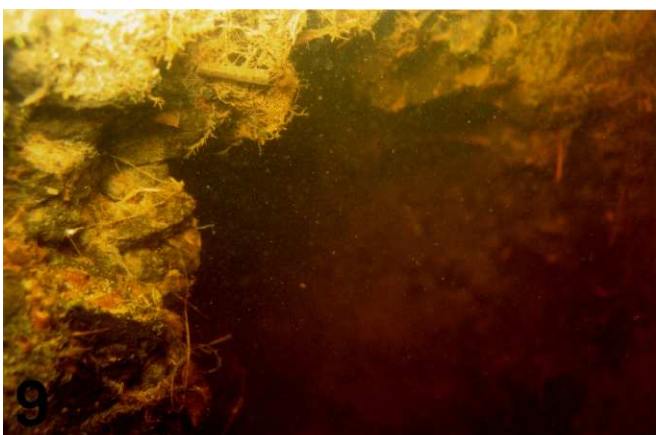
Underwater inspection showed considerable erosion of the earth below the water line due to insufficient protection against erosion. At some places the original underwater ground level has been eroded down to the same level as the bottom of the base of foundation. Comparatively deep scoured areas in concrete footings were found on the sides faced towards the river flow. Maximum damage reached depths of 1.3 m (fig.4).

Fig.4. The scouring damage of concrete foundation of the bridge over river Salaca

might affect carrying capacity. Erosion is caused by heavy particles suspended in water flowing across concrete surfaces of bridge footing. Between piers Nr.1 and Nr.2 there are considerable alluviums which reduce the cross-section of river bed and thus the stream flow at piers Nr.3-5 is accelerated to form scouring of the ground and eventually the The bridge over river Salaca did not have any kind of pier footing protection. scouring of concrete footings appears (fig.5).

It can be assumed that the ground erosion and concrete footing scouring was progressing 100 years. Any kind of deformation of the superstructure due to settlement or movement was not detected. It is necessary to repair the damage and build footing protection. The damage of footing

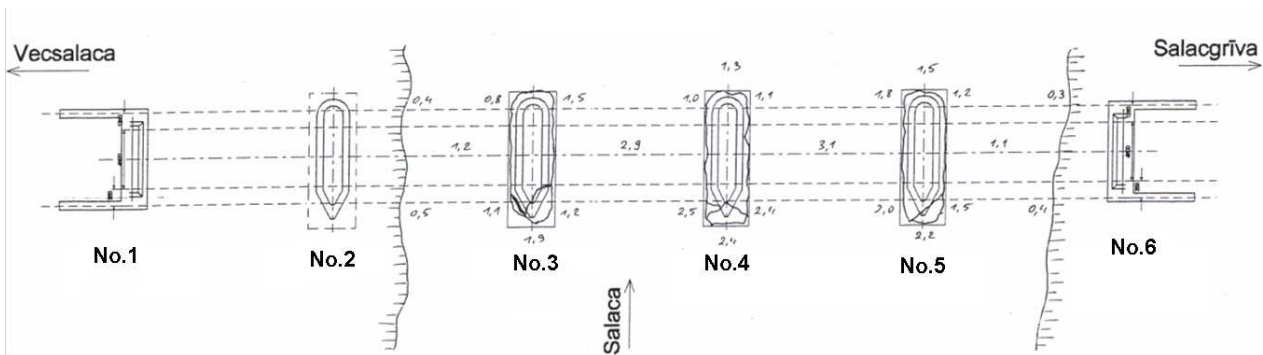
Fig.5. The plan of piers and foundation damage of the bridge over river Salaca

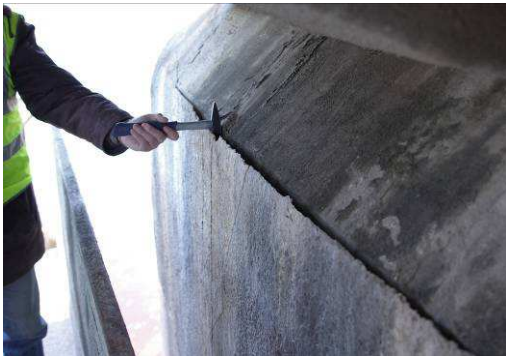
Fig.6. Delimitation of shotcrete layer of pier positioned below faulty expansion joint

The piers of the bridge over river Gauja have been repaired in 1997. Non sealed expansion joints caused consequential damage to the piers which are positioned below the expansion joints. Delimitation of repaired concrete layer (shotcrete layer) was detected to one of the piers (fig.6.). Figures 7 and 8 show that 10 years after repair piers look about the same they were 20 years ago.

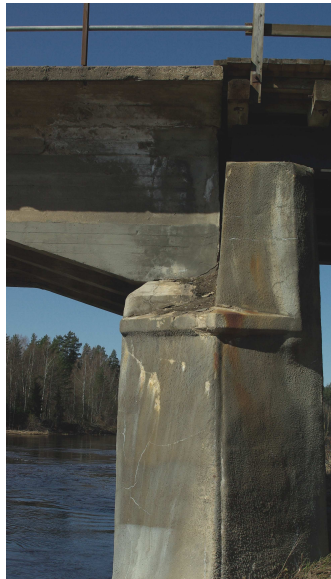
Fig.7. Repaired pier in 2008

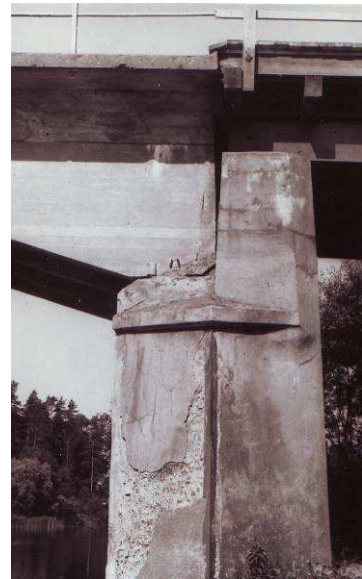
Fig.8. Pier before repair in 1985

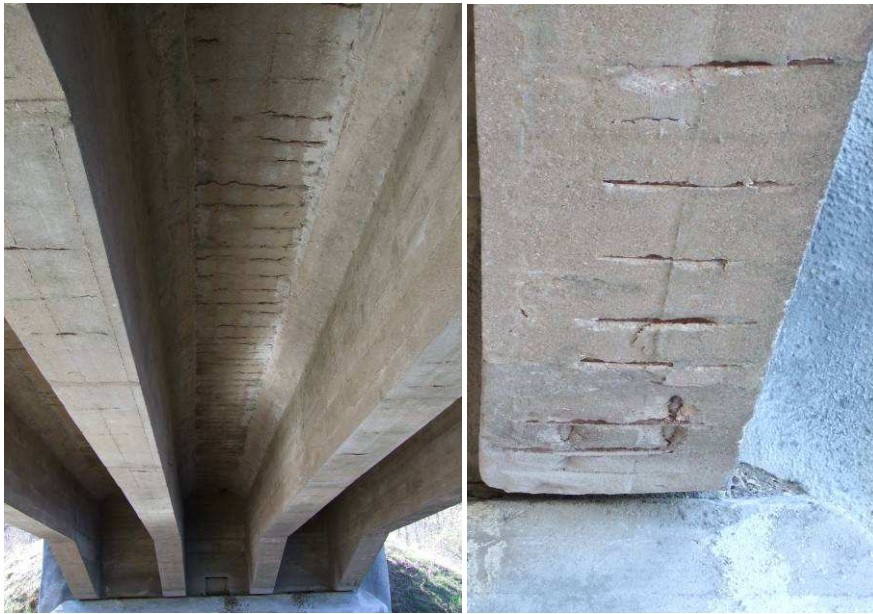
Spalling of small portions of concrete due to corrosion of reinforcing steel and insufficient concrete cover to the underside of beams and slab (fig.9.). Concrete cover measurement results show that it is very variable. At several places the main reinforcement corrosion was detected due to carbonation and longitudinal cracks along the reinforcement.

Fig.9. Spalling of the concrete due to insufficient concrete cover and corrosion of reinforcement

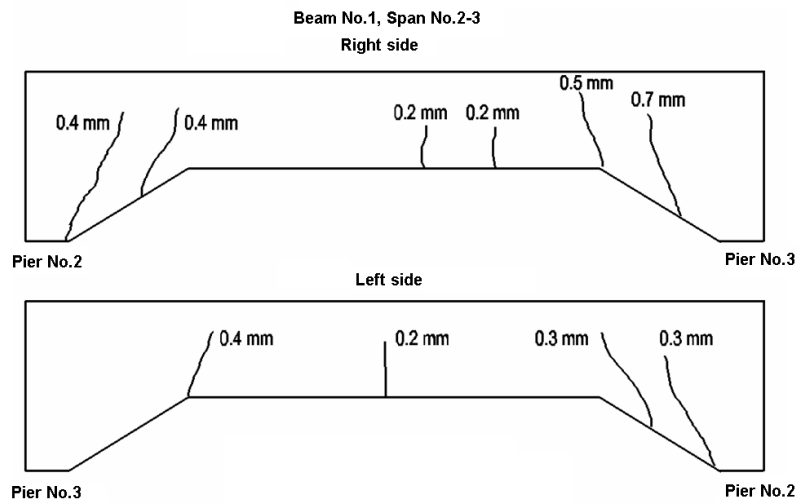
Shear cracks on beams up to width of 0.7 mm (fig.10). The cause of the shear cracks have been caused by overload of the structure at some point of the time (perhaps during the World War II).

Fig.10. Position and width of shear and flexure cracks on beams

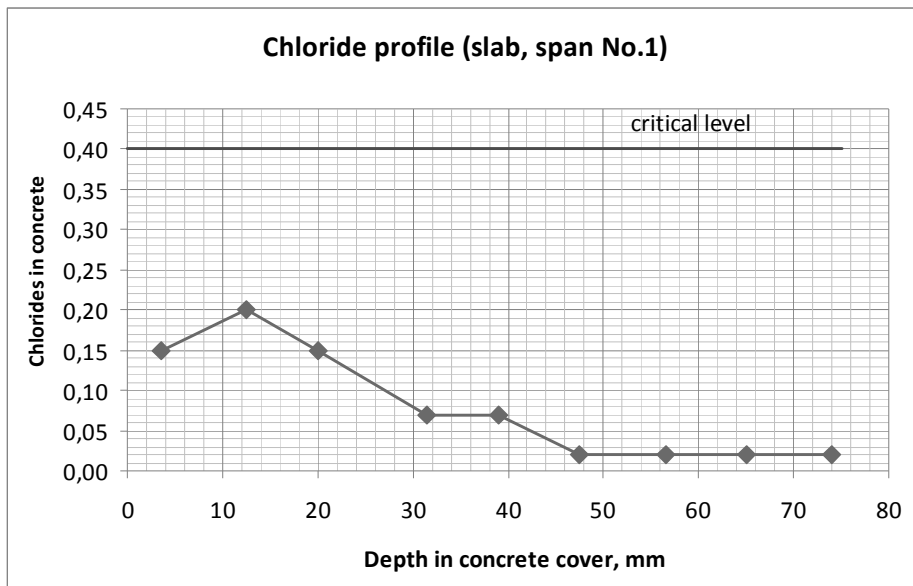
The saturation of chlorides in concrete bridge slab was found low reaching only 0.20% of the weight of the concrete (fig.11). The bridge is not exposed to chlorides or de-icing salts. The average carbonation depth was found about 40 mm (fig.12). Carbonation initiated corrosion was found on the underside of beams and slab with insufficient cover (10 to 30 mm).

Fig. 11. The chloride profile taken from the top surface of the bridge slab

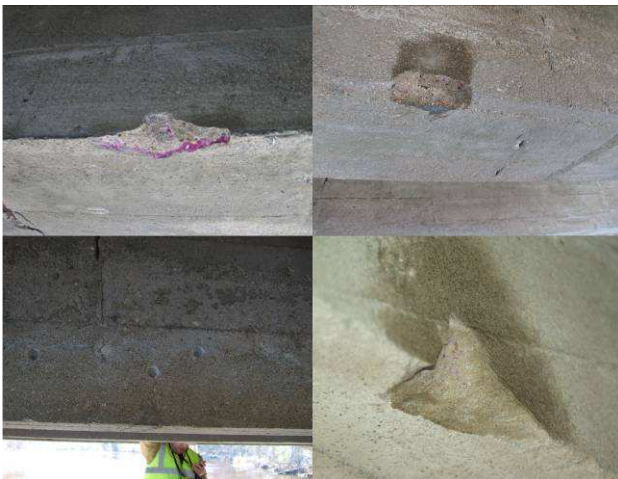
Fig. 12. Determination of the depth of carbonation of the concrete

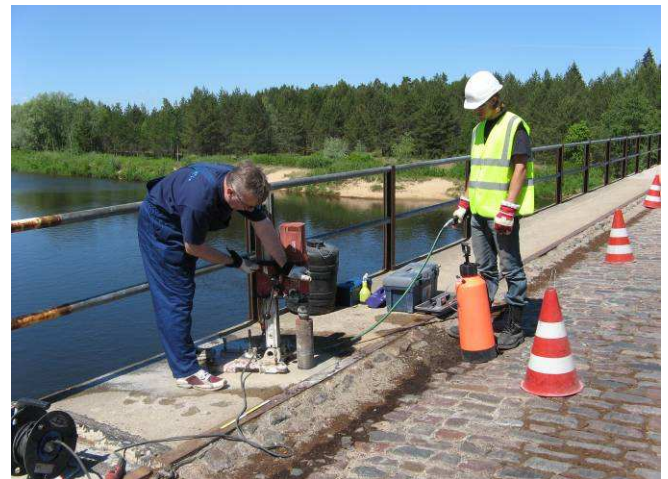
Pressure testing of drilled core was performed to determine the strength of the concrete (fig.13). Pressure testing showed good compatibility to jackhammer test performed at different positions of the bridge. The results showed 49.9 N/mm² compressive strength which applies to the C40/50 concrete.

Fig. 13. Concrete core drilling
