## ANALYSIS OF QUALITY CONTROL PLANS FOR BRIDGE OVER THE RIVER MAZA JUGLA ACCORING TO COST TU 1406 METHODOLOGY

Roberts Auzins<sup>1</sup>, Ainars Paeglitis<sup>1</sup>

<sup>1</sup>*Department of Roads and Bridges, Civil Engineering Faculty, Riga Technical University, Riga, Latvia*

This article analyses and compares different Quality Control Plans developed according to COST TU 1406 methodology for the existing bridge over the river Maza Jugla, located on regional road P10 at km 34.80 in Latvia.

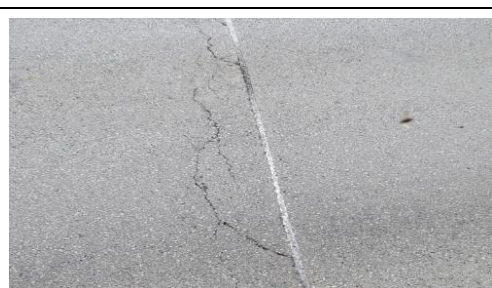
Fig.6-2. Saw cut in asphalt pavement
