EXPERIMENTAL EVALUATION OF DAMAGE INFLUENCE ON BUCKLING PERFORMANCE OF STIFFENED CFRP SHELLS

O. Ozoliņš, K. Dzelzītis, E. Eglītis

Keywords: buckling, post-buckling, delamination, non-destructive inspections

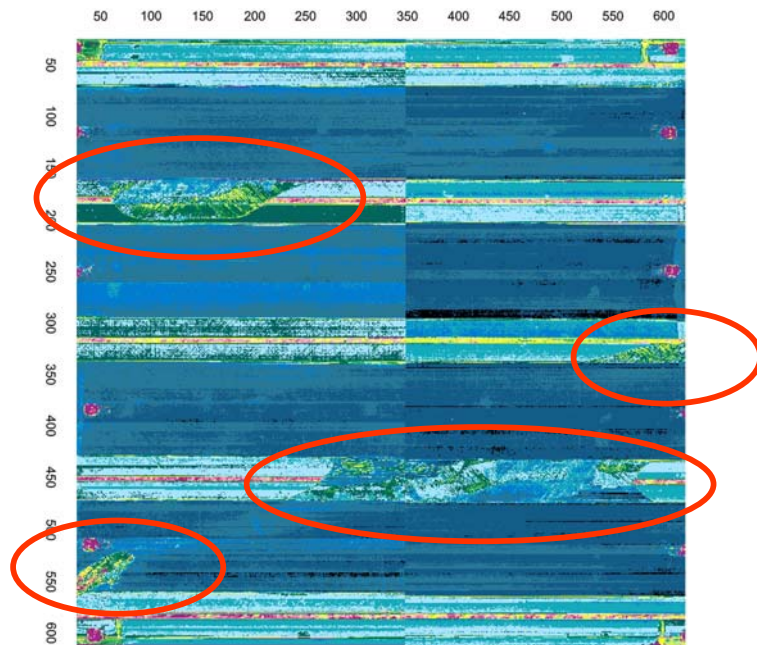
Fig. 4
Ultrasonic backwall response of the COCOMAT 6A panel

According to the acquired ultrasonic responses (Fig. 4 to Fig. 6), explicit skin-stiffener delamination has occurred. Visual inspection approved that the second stiffener has detached from the skin of the panel. Detailed pictures of the delaminated area between the skin and stiffeners are shown in Fig. 7.

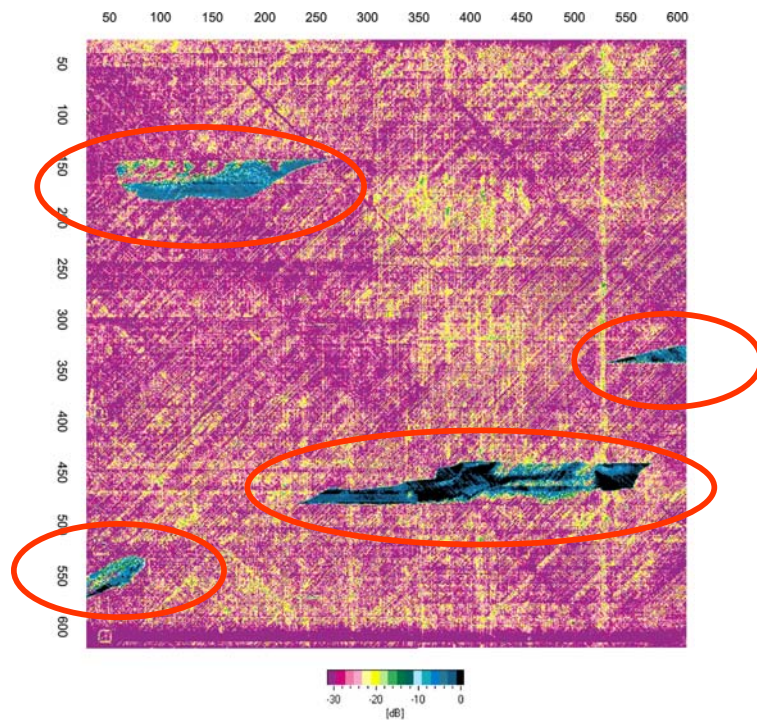
Fig. 5
Ultrasonic flow echo response of the COCOMAT 6A panel

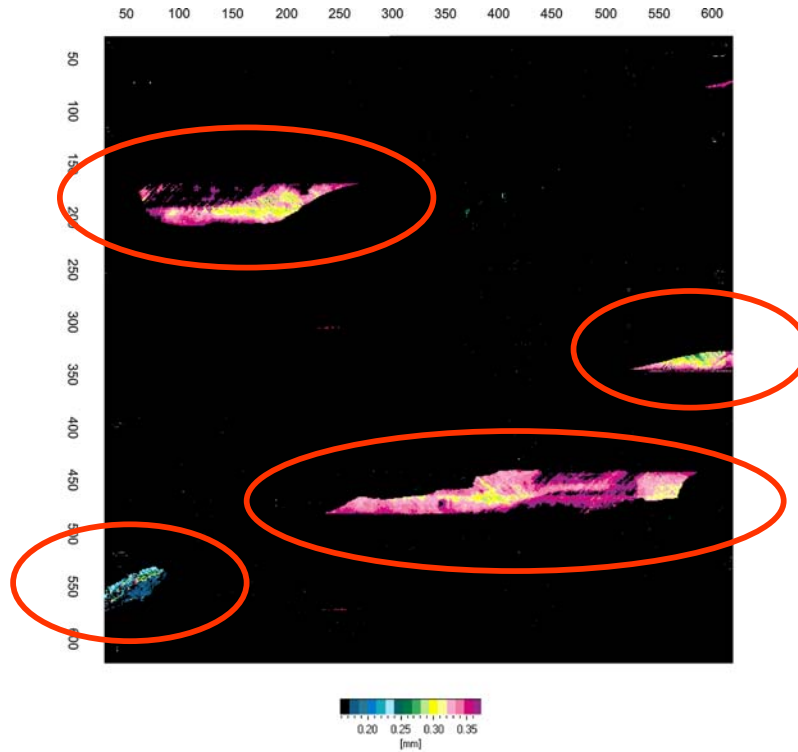
Fig. 6
Ultrasonic flaw depth response of the COCOMAT 6A panel

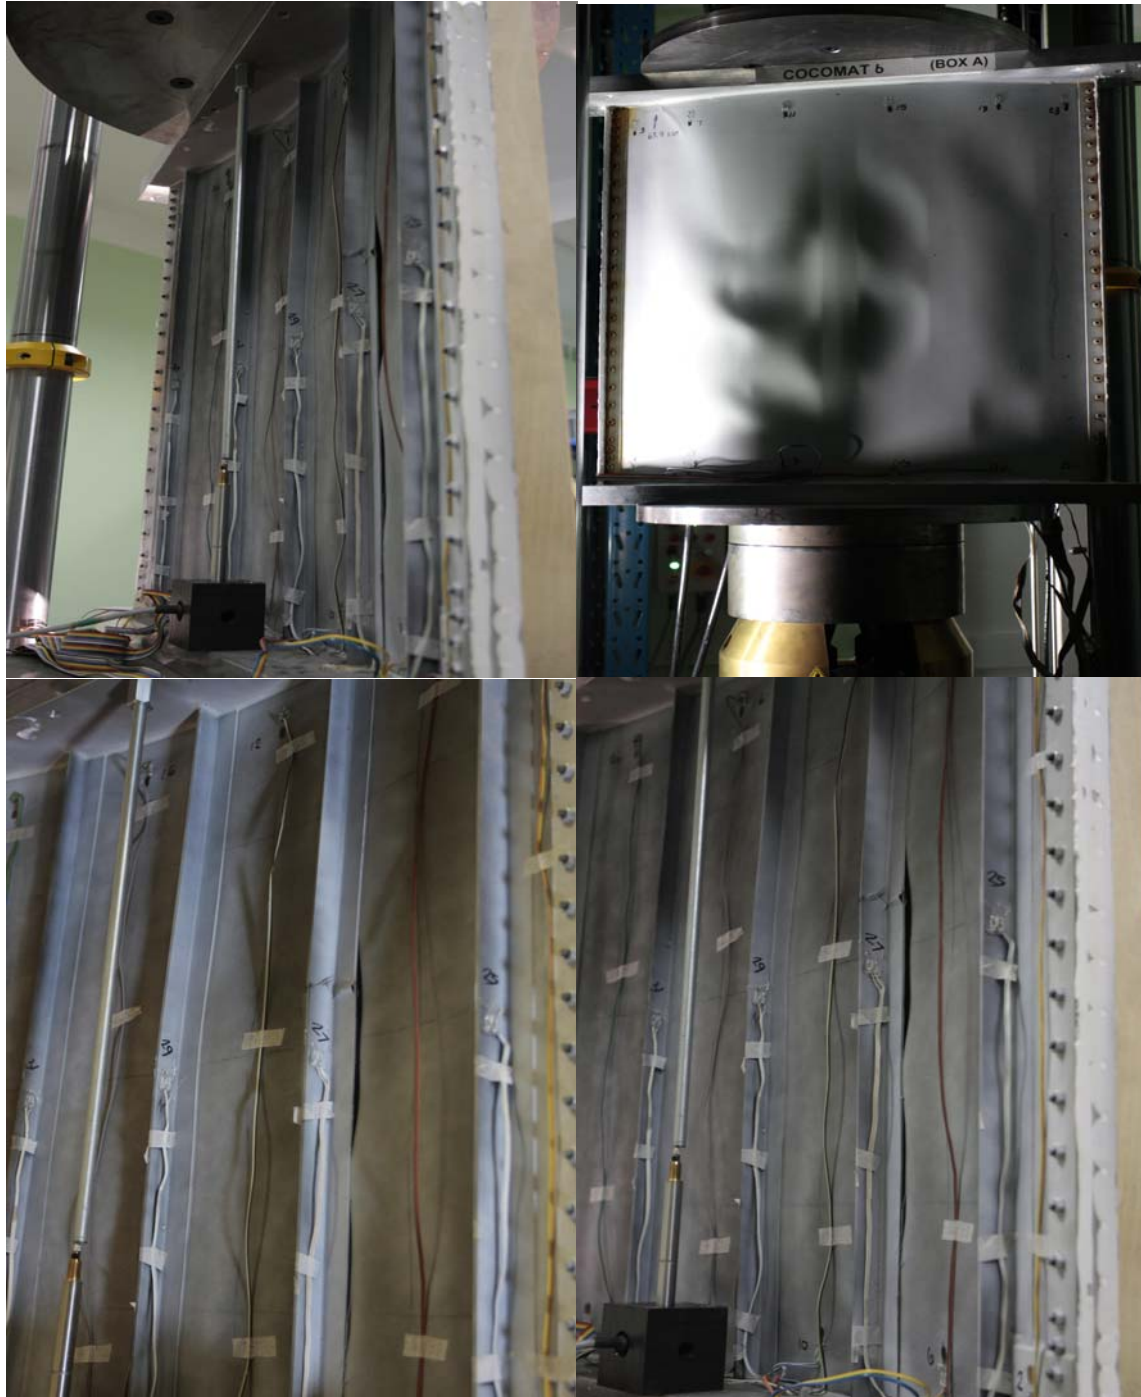
The other delamination areas discovered by ultrasonic inspection were undetectable by visual observations. Moreover, comparison of the COCOMAT 6A and 6B panel ultrasonic inspection test results shows that the panel 6B has been subjected to lower load level than the panel 6A and therefore avoided the intensive delamination growth before the collapse of the structure and has no significant damage.

Fig. 7
Delamination presence between the skin and stiffeners COCOMAT 6A

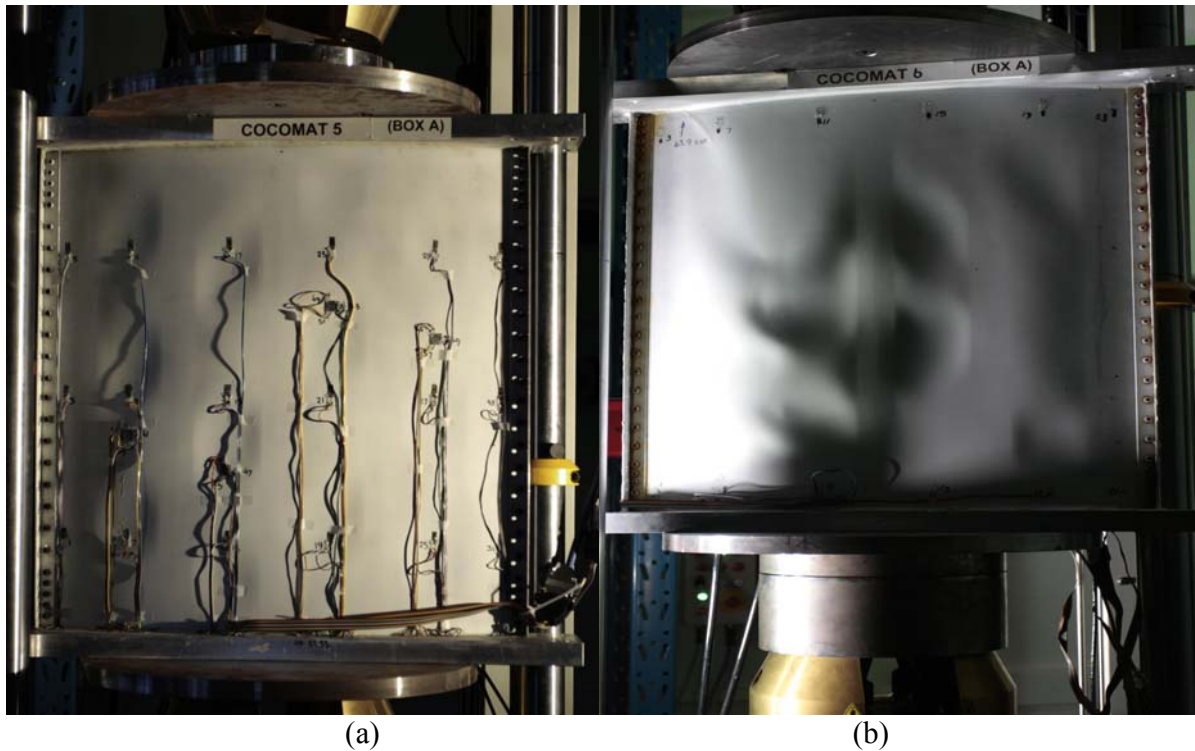
Fig. 8
Deformed shape of non-damaged (a) and damaged (b) panels at 115 kN load

As seen in Fig. 8, the panel without damage (a) has more regular buckling mode shape pattern than the one with stiffener delaminations (b). This indicates that the load distributes less uniformly across the panel width in the damaged specimen, thus resulting in stress concentrations, which can lead to further delamination growth or material failure. Stress misbalance can considerably decrease the load carrying capacity of the panel, especially in the post-buckling region.

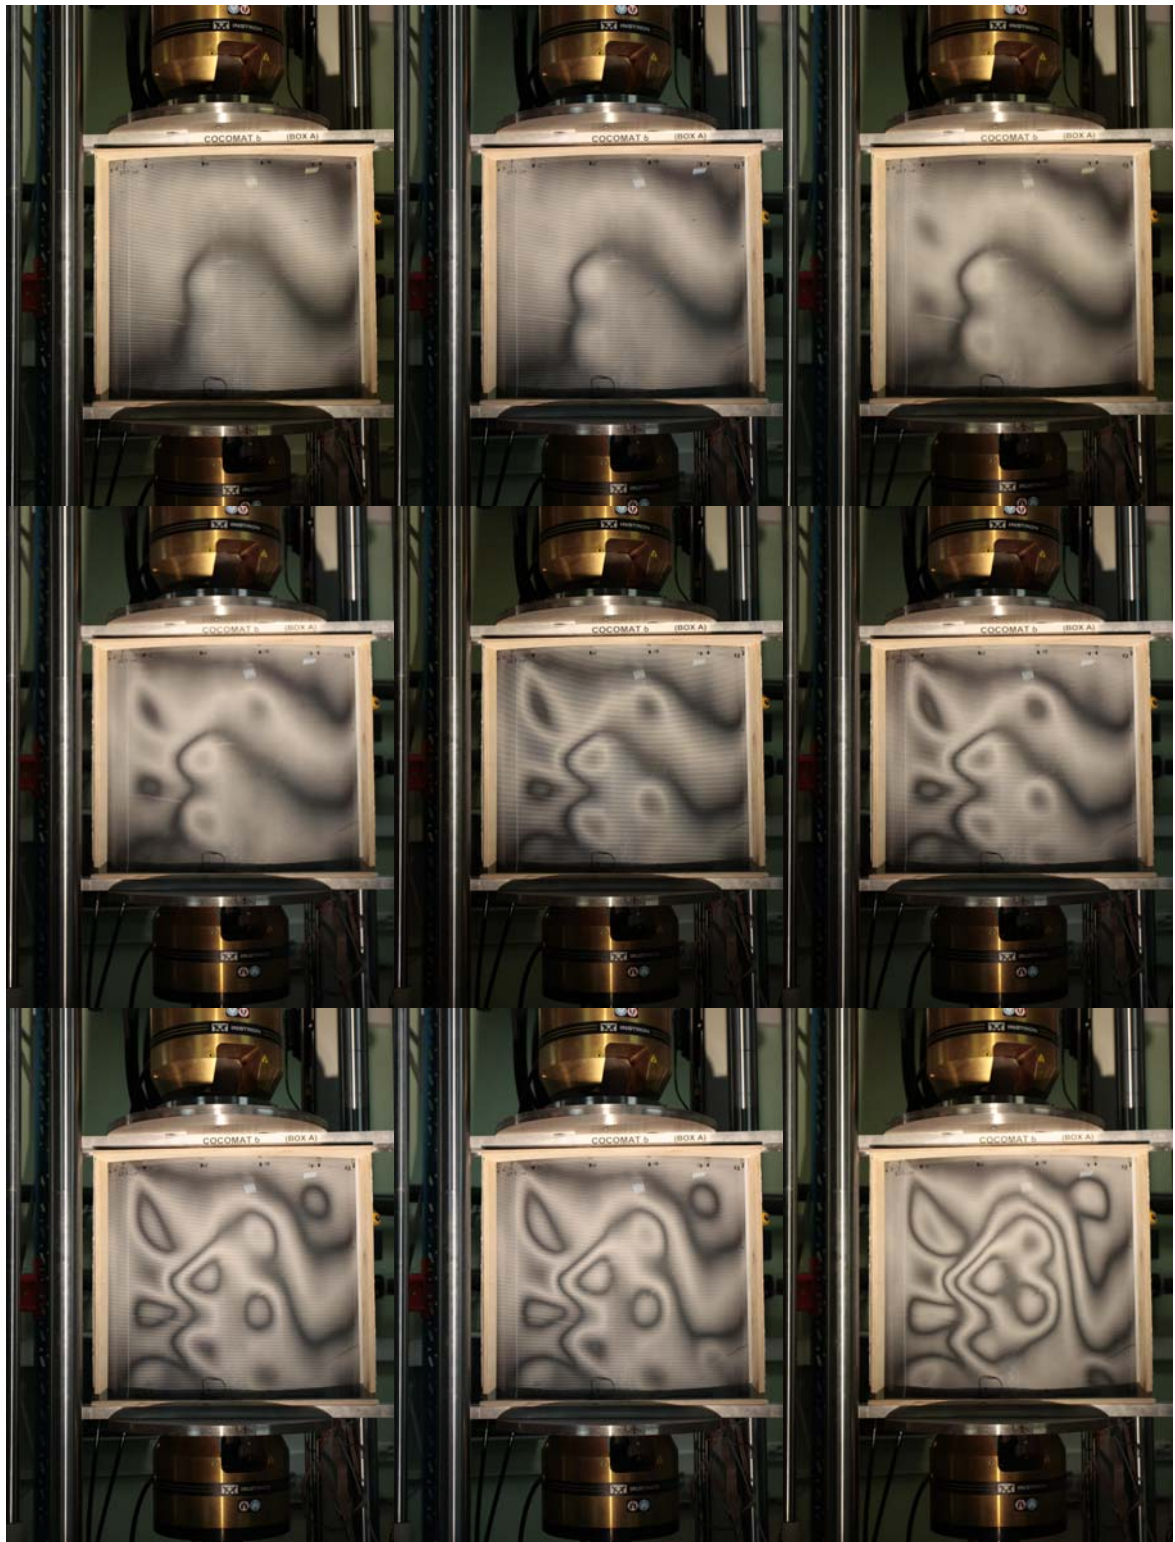
Fig. 9
Evolution of buckling and postbuckling mode shapes for damaged panel

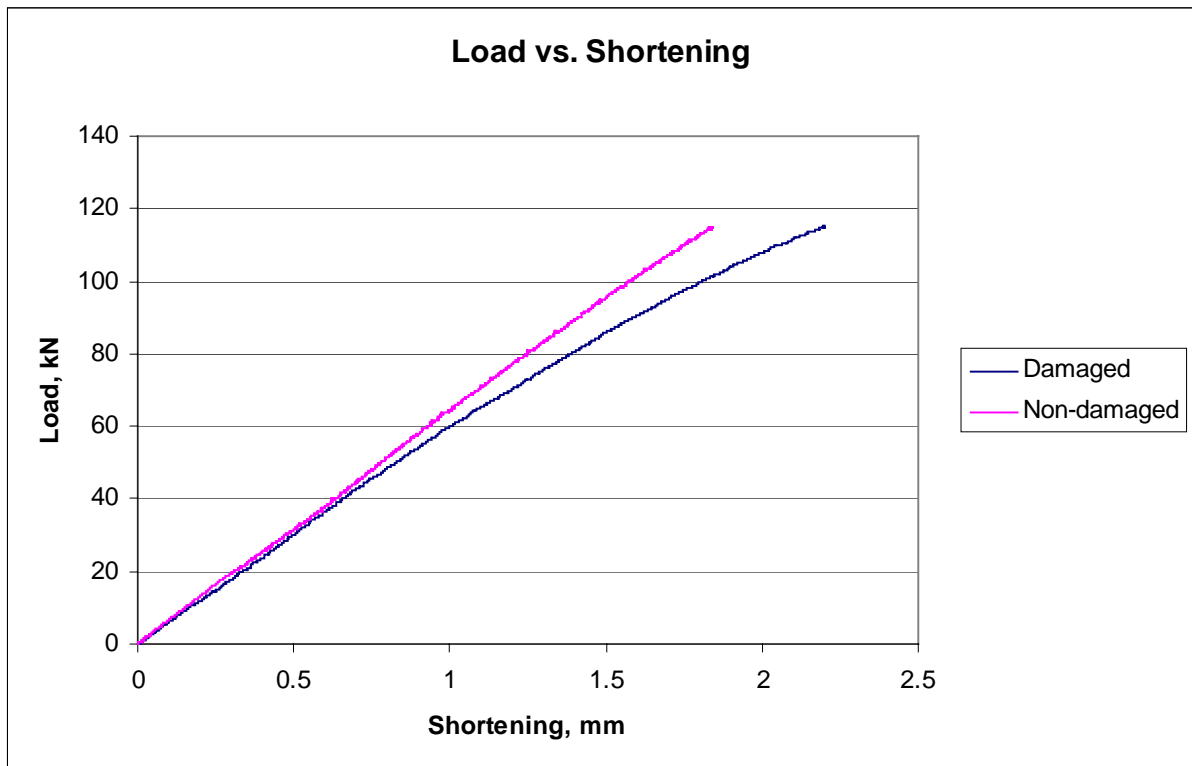
Fig. 11
Load vs. Shortening comparison for damaged and non-damaged panels.

Comparison of the panel performance at the 114.5 kN maximum load in post-buckling region and the skin buckling loads is presented in Table 1. Approximately 16 % of the overall stiffener flange area of the damaged panel had delaminated, as detected by ultrasonic inspections, resulting in decrease of skin buckling load and post-buckling stiffness. At the maximum load applied to the specimens, the damaged panel had shortened 20 % more than the undamaged panel. This is the result of the 35% decrease in the post-buckling stiffness and 35% decrease in the skin buckling load.

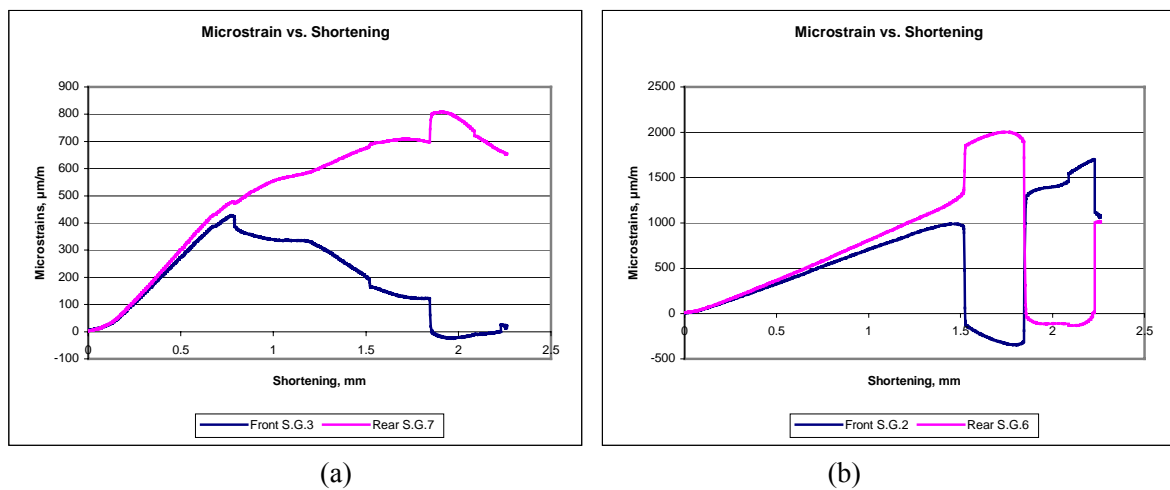
Fig. 12
Strain gauge measurements in RTU tests of damaged panel

Despite the decrease in the stiffness characteristics of the structure for the damaged specimen, the buckling occurs at almost identical strain level for both panels, which stays the same through the whole loading range. At the maximum load, the strains recorded by the strain gauges are 6% lower in the damaged panel than they are in the undamaged one. This can be partly explained by different locations of the strain gauges on the specimens, as explained in the chapter 4.1.
