2019, vol. 23, no. 1, pp. 122–134 doi: 10.2478/rtuect-2019-0009 https://content.sciendo.com

In-Situ Moisture Assessment in External Walls of Historic Building using Non-Destructive Methods

Ritvars FREIMANIS¹*, Rasa VAISKUNAITE², Tereza BEZRUCKO³, Andra BLUMBERGA⁴

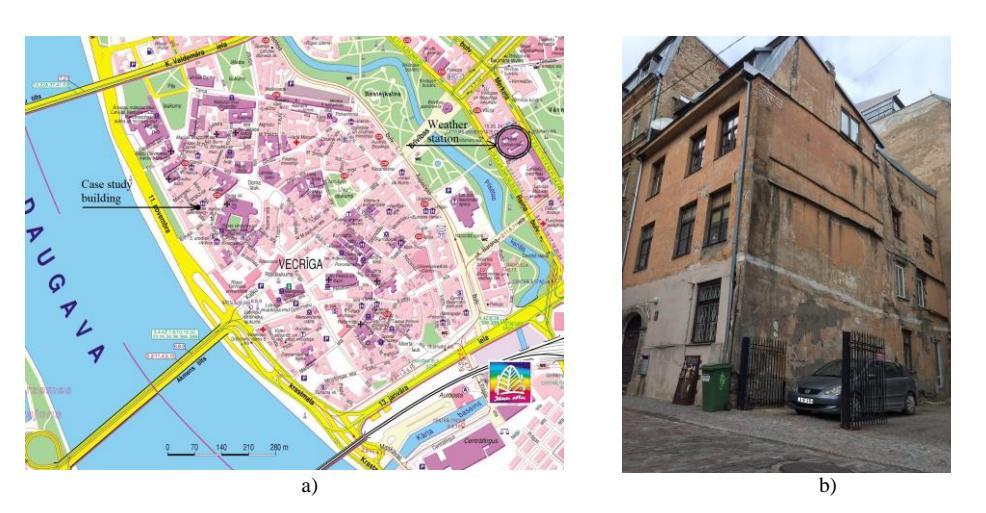
The case study building at Biskapa gate 6 in Riga, Latvia was selected for the in-situ measurements. This particular building was selected, because of complaints from building residents about the discomfort, in the form of increased indoor humidity levels. Another reason for choosing this building was the visible deterioration of the façade (Fig. 1).

Fig. 1. Case study at Biskapa gate 6: a) location of building and weather station in map; b) façade of the building [15].

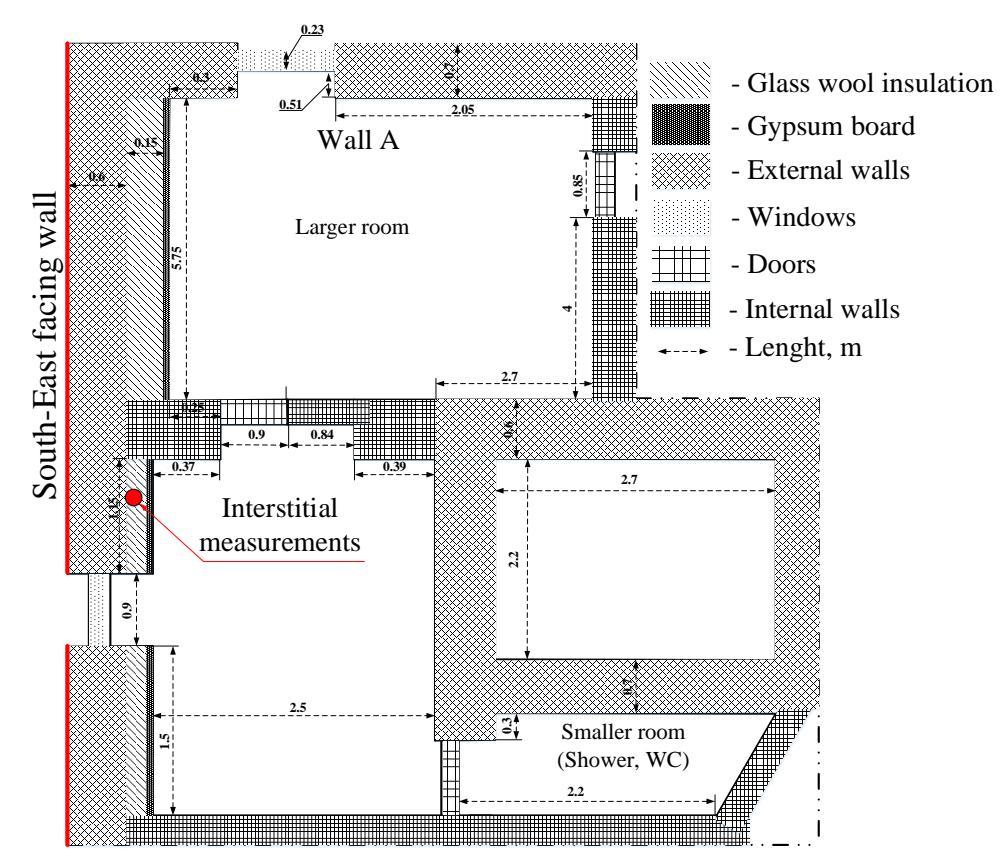
Fig. 2. Cross section of monitored wall with measurement points.

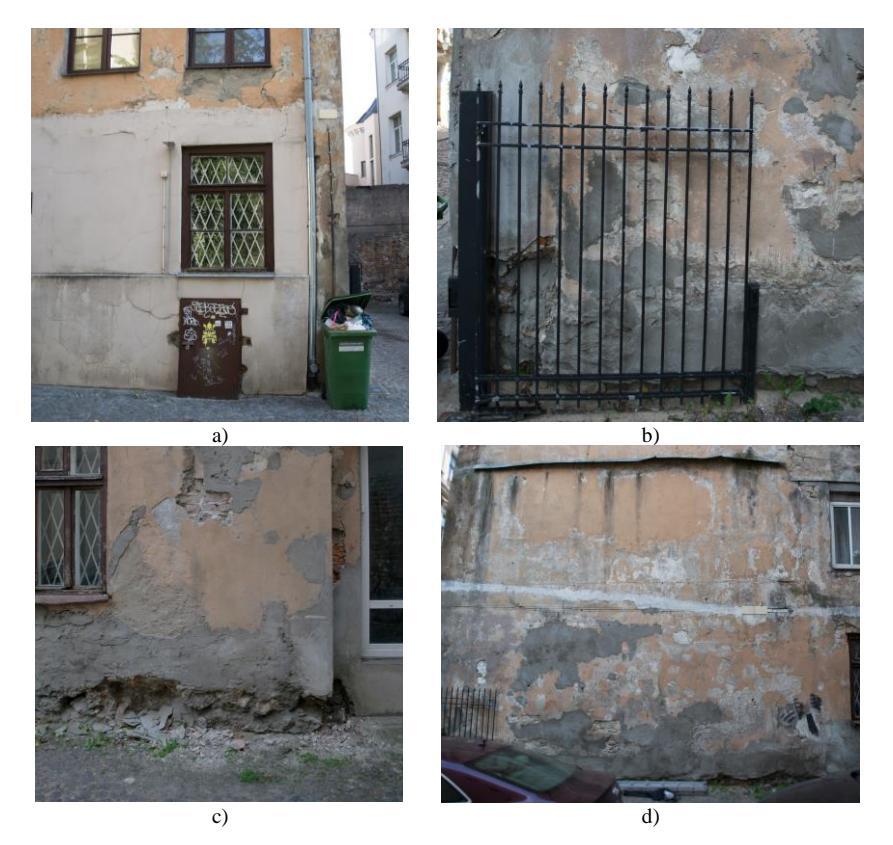
Visual inspection of the façade revealed severe material loss, i.e. plaster and reduced masonry thickness at the ground level. Moreover, multiple cracks and poor-quality craftsmanship was noticeable. Algae growth was also evident on some parts of the façade. However, no sign of efflorescence was noticed. There was also an observation of some repair jobs carried out, where some of the lost material (plaster, bricks) had been replaced with cement. Near the ground level on the west-facing wall, a loss of building material was observed. Material loss was most severe on the edges of the wall and under the window but was almost undetectable on the front facing wall (Fig. 3).

Fig. 3. Façade of the building: a) South-West façade; b) South corner; c) right corner of South-East façade; d) South-East façade.

Obtained results show the loss of external plaster is obvious in many areas of the façade, combined with cracks, and cuts. These open areas allow outdoor moisture i.e. wind driven rain, to easily penetrate the wall. Algae growth on the façade indicates that rain water has been present on the walls' surface.

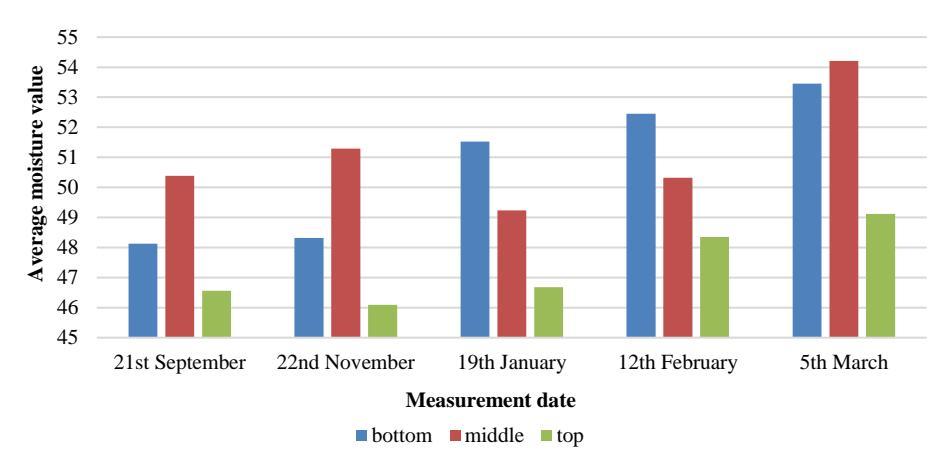
In Fig. 5 changes of average values in top, middle and bottom sections, for 20 cm depth measurements are presented. There has been an upward trend at the bottom section of the wall, during the measurement period. Likewise, the top section follows the upward trend, with the slight decrease from 1st to 2nd measurement. The moisture measurements of the middle section had a drop of average moisture value in January, but afterwards they start to follow an upward trend.

Fig. 5. Average moisture value changes for 20 cm depth measurements.

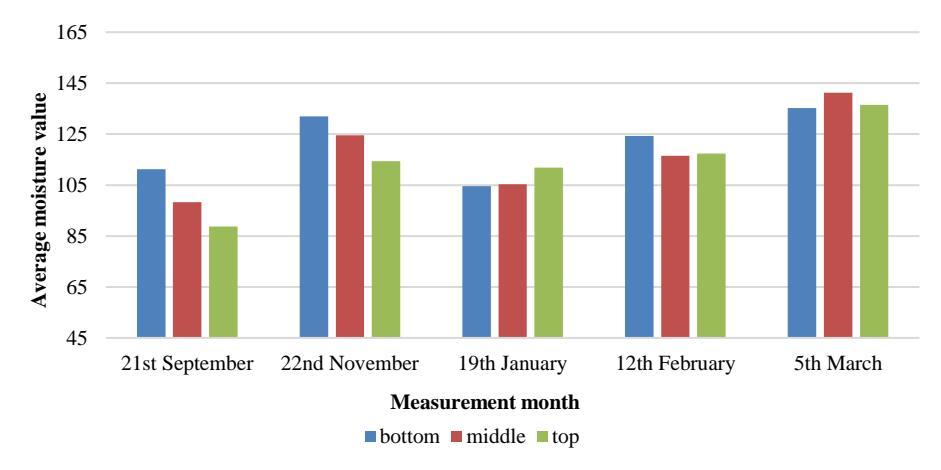
In Fig. 6 changes of average values in top, middle and bottom sections, for 2 cm depth measurements are illustrated. The 2 cm depth measurements follow a very similar trend as the 20 cm depth measurements in the middle section, with an increase in the period from the September to November, followed by a drop and then continuing an upward trend.

Fig. 6. Average moisture value changes for 2 cm depth measurements.

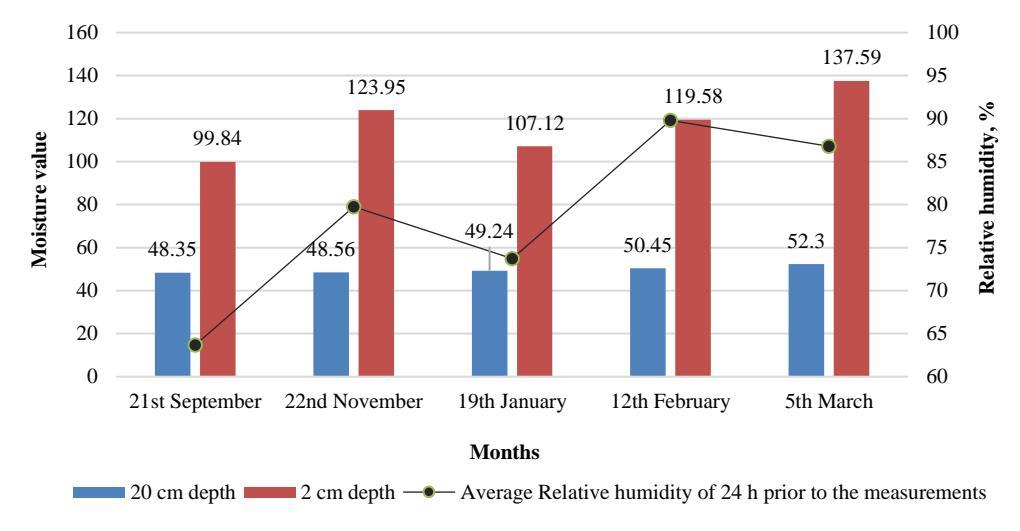
In Fig. 7 the average moisture measurement values are compared to each other and to average relative humidity period of 24-hours, prior to the measurements. It can be seen that 2 cm depth measurements, that represent moisture values near the surface, are more than two times greater

than 20 cm depth measurements that represent moisture values 20 cm inside the masonry. During the measurement period, average 20 cm depth measurements change only by 3.5 during the whole period, but maintain the upward trend. 2 cm depth measurements on the other hand fluctuate and change by a total of 37.75 during the measurement period.

Fig. 7. Average values of the wall moisture measurements and outdoor relative humidity

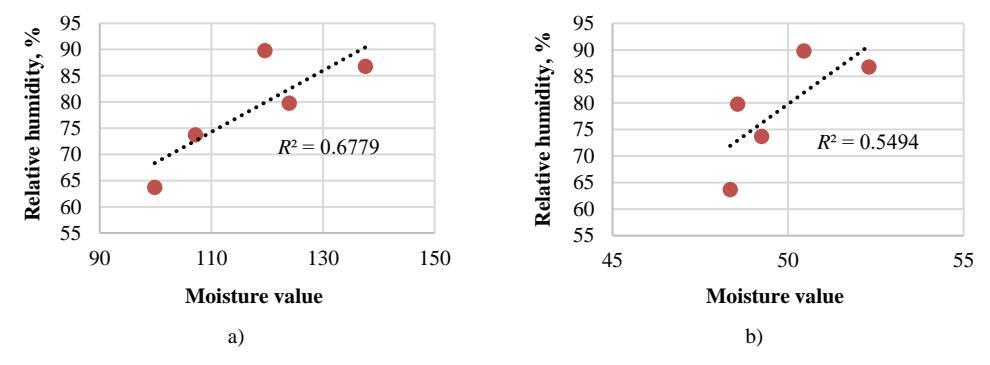
In Fig. 8 the correlation between the outdoor relative humidity and wall moisture is presented. The correlation observed is good for 2 cm depth and little less for 20 cm depth.

Fig. 8. Correlation between outdoor relative humidity and: a) 2 cm depth measurement values; b) 20 cm depth measurement values.

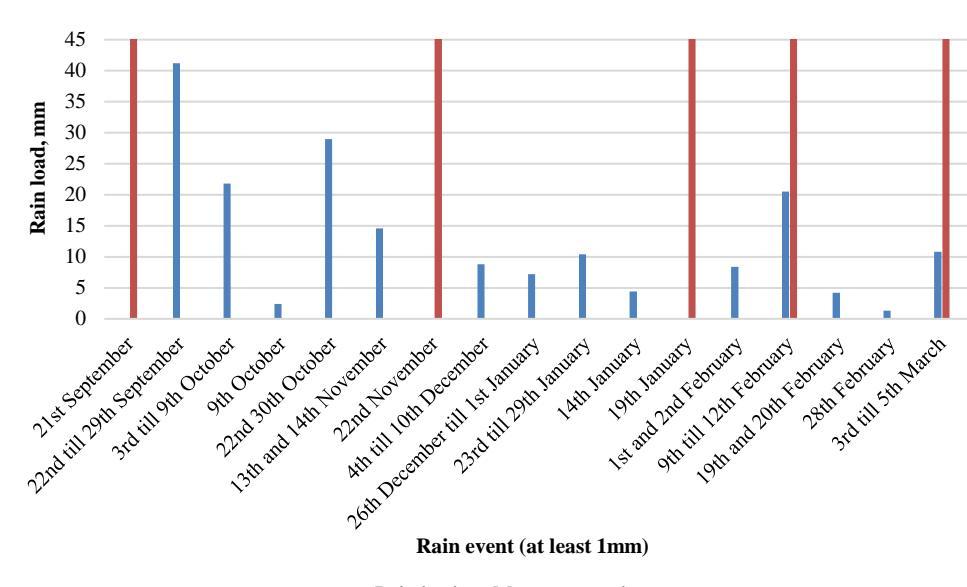
Rain load events with the total amount of rain 1 mm or greater are shown in Fig. 9. Total rain event is greater between 1st and 2nd measurement, than between the 2nd and 3rd measurements. That could explain the sudden drop of average moisture values in the 3rd measurements (in 19th January). Moreover, the 4th and 5th measurements, that have shown the highest average moisture values, are made right after the rain event.

Fig. 9. Rain load event during the monitoring period.

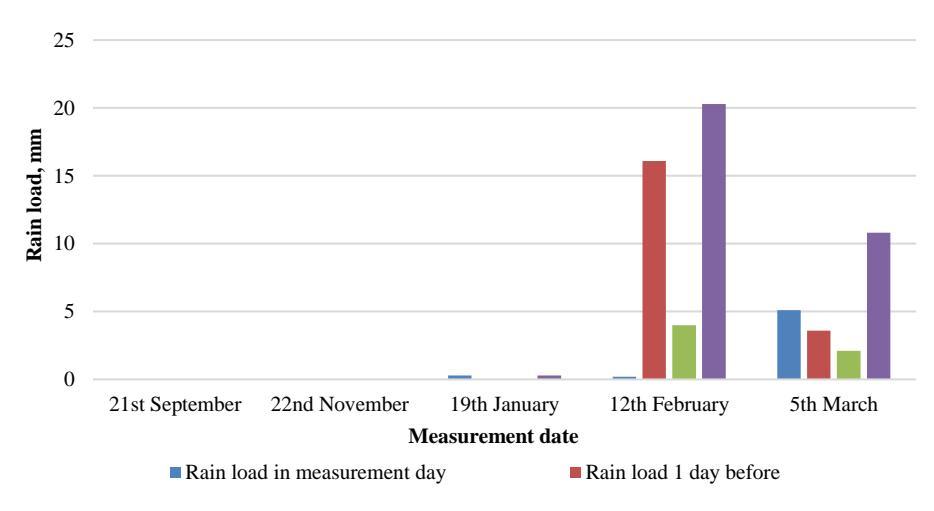
24-hour cumulative rain events of three consecutive days prior to the measurements are presented in Fig. 13. When comparing Fig. 7 with Fig. 10, it can be seen that on the 12th February when the total rain load is higher (by 9.5 mm), the average 2 cm depth measurement is slightly lower (by 18.01) than on March 5th. However, the rain load during March 5th is higher (by 4.9 mm) than on February 12. After comparing average moisture values of 2 cm depth measurements with the rain event from Fig. 10, it can be seen that the average moisture value is affected more by the rain load event 24-hours before the measurement, rather than total rain load event of the 3-day period prior to the measurement.

Fig. 10. Rain load of three days prior to the measurement.

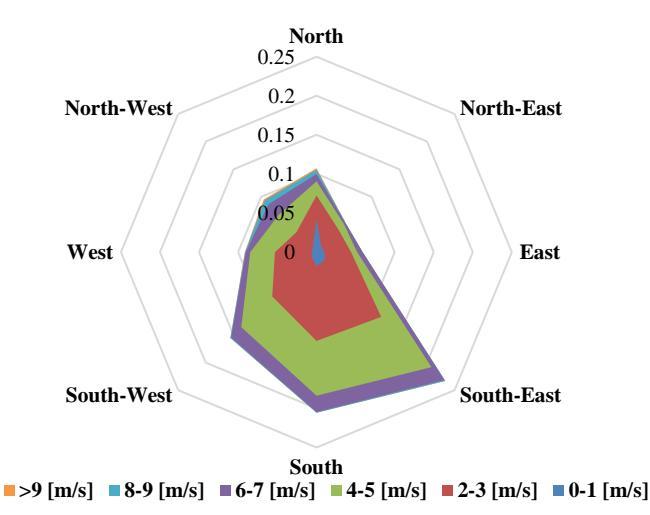
The dominant winds and wind speeds during the monitoring period are shown in Fig. 11. Over the period of three days prior to the measurements on 12th February and 5th March, the following wind conditions were observed:

- 12th February 58.46 % of wind comes from the South, followed by 13.58 % from South-West with a dominant speed of 5 m/s;
- 5th March 47.69 % of wind comes from the South west followed by 18.6 % from South, with a dominant speed of 3 to 5 m/s.

Fig. 11. Wind direction and speed during the monitoring period.

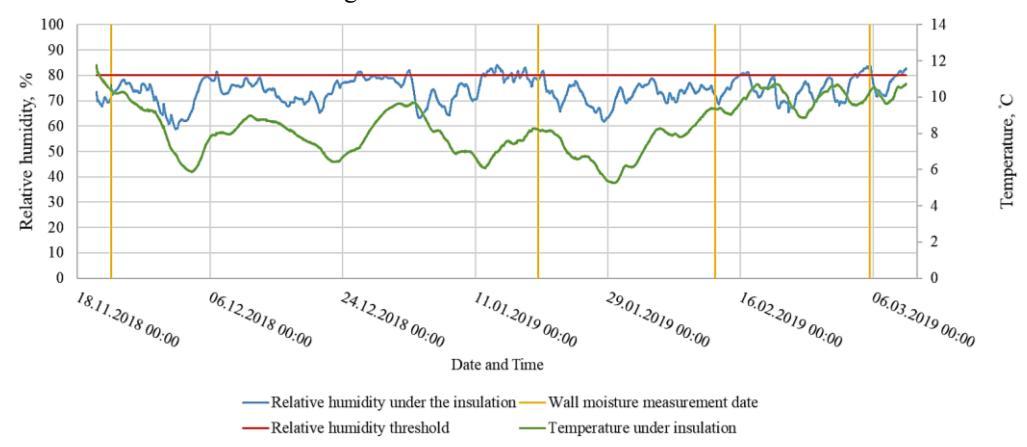
Fig. 12 present relative humidity and temperature measurements during the monitoring period. It can be seen that relative humidity under the insulation material stays mainly below 80 % that has been considered as the critical moisture when the mold growth would occur. Relative humidity fluctuates during the monitoring period from 58.85 % to 83.9 % and on the average is 74 %. It also can be seen that temperature under the insulation material stays above 0 °C that reduces the risks of freeze thaw cycles to occur. During the monitoring period temperature fluctuates from 5 °C to 11.5 °C and on the average is 8.4 °C.

Fig. 12. Relative humidity in the insulation system.
