RIGA TECHNICAL UNIVERSITY
Faculty of Mechanical Engineering, Transport and Aeronautics
Institute of Aeronautics

**HELICOPTER STRUCTURE FATIGUE DEFECT
ACOUSTIC DIAGNOSTICS WITH DEFECT LOCALIZATION**

Summary of the Doctoral Thesis

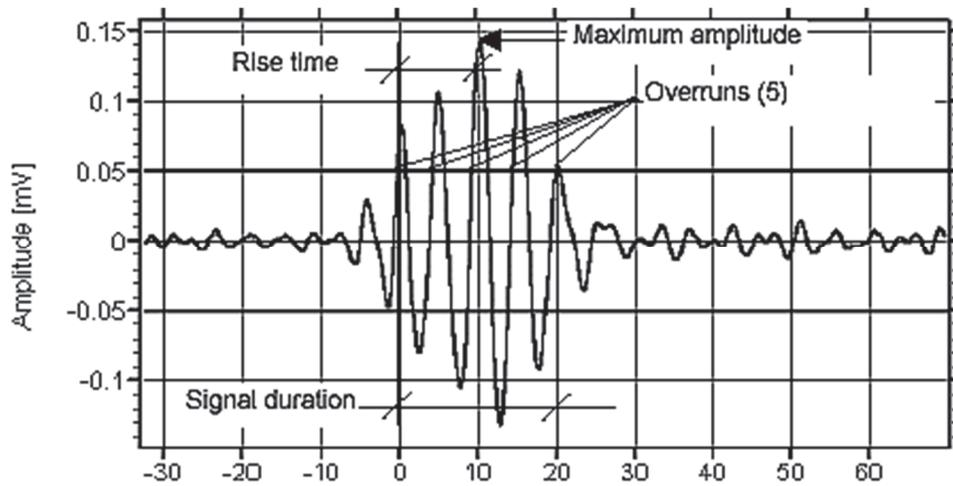
AE signals are characterized by amplitude, duration, form, and rise time (Fig. 1.1.). Similarly, the signal flow can be characterized by the event's statistical average frequency, spectral density, amplitude and time dispersion, average value, and dispersion. Each of the mentioned characteristics is related to the physical process caused by AE, and its determination can provide information on the condition of the object.

Fig. 1.1. AE parameters.

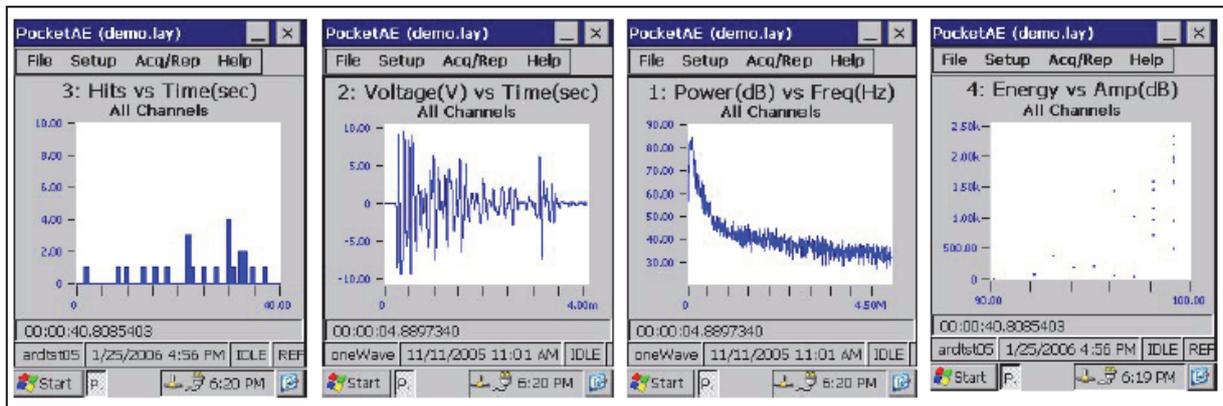
Fig. 2.1. Possibilities of the *PAC Pocket AE-2* graph.

During research, the following devices were used: the multi-channel AE control equipment *PAC Pocket AE-2* [71], and *A-Line 32D (DDM)* [97]. The AE control device *PAC Pocket AE-2*, manufactured by *Physical Acoustics Corporation*, has “hit-based” architecture and is a portable, hand-held, 2-channel AE facility. *A-Line 32D (DDM)* is a digital multi-channel acoustic emission measurement system for acoustic emission data recording and processing.

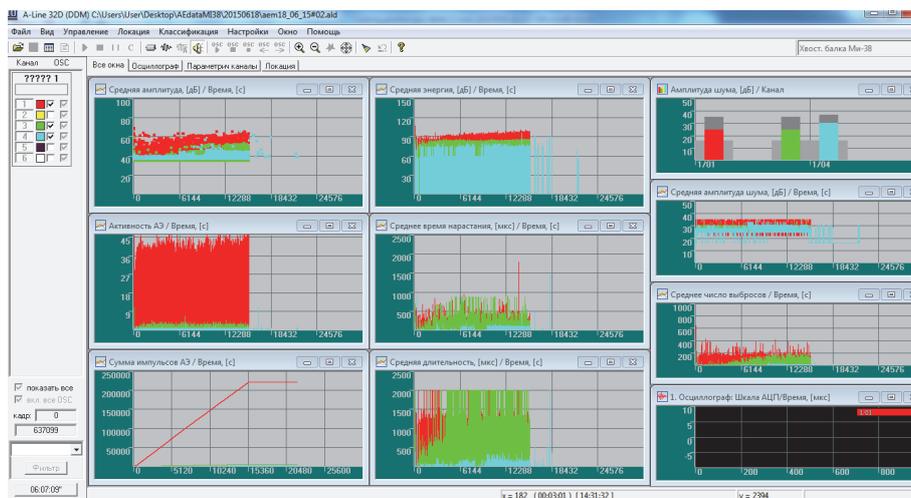
Fig. 2.2. *A-Line 32D (DDM)* visualization.

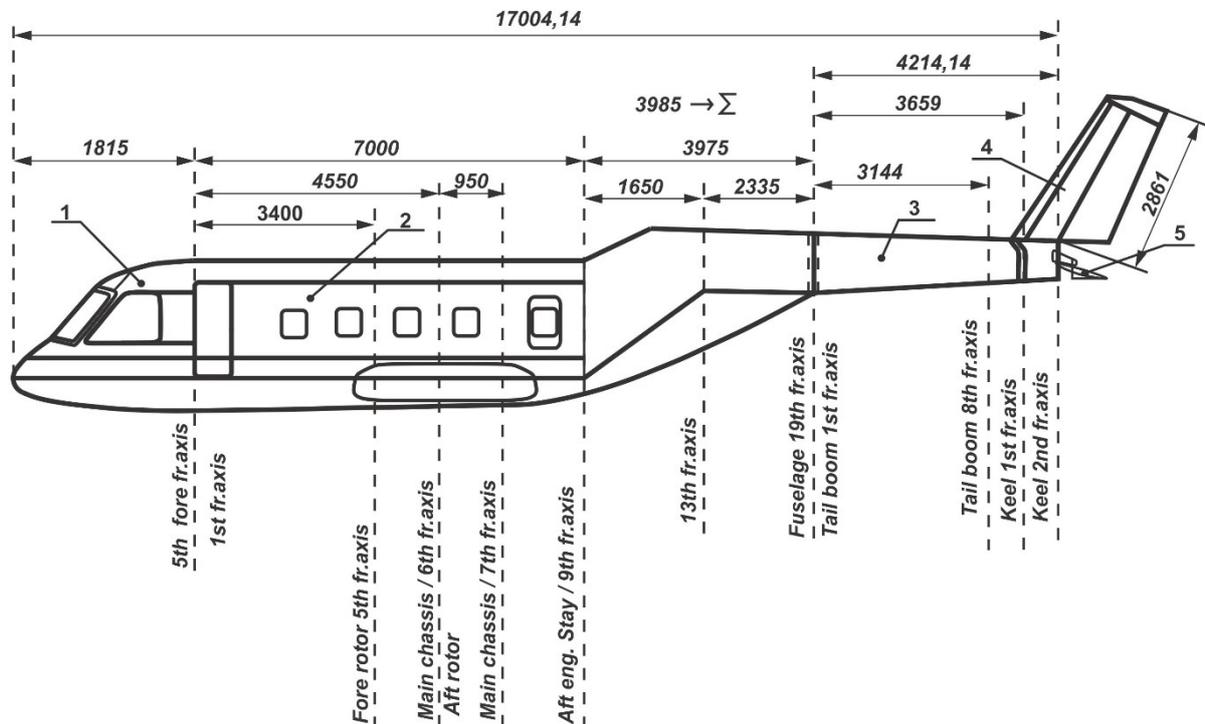
In general, the fuselage (Fig. 2.3.) strength scheme includes a coating consisting of longitudinal and traverse bonding elements.

Fig. 2.3. Helicopter fuselage structure.

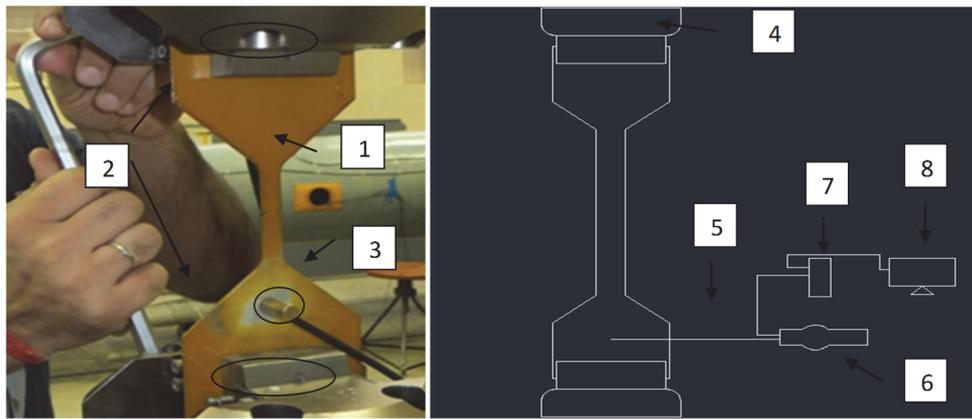
Fig. 2.4. Location of AE sensors on a sample, and sample test scheme [56, 61]:

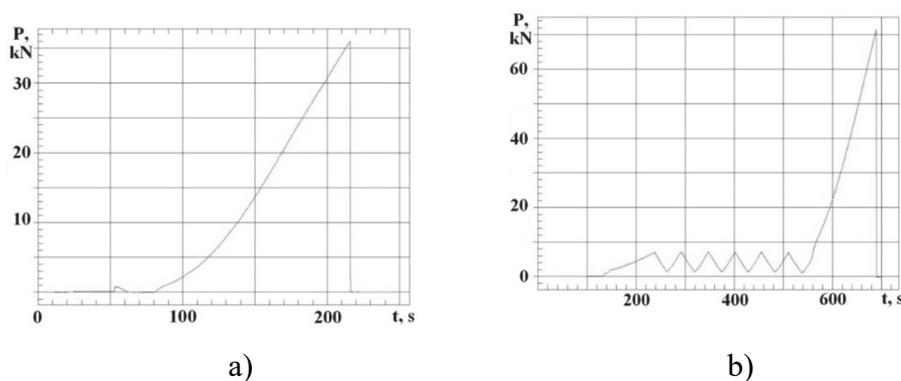
Fig. 2.5. The schedule of loading the specimen with longitudinal arrangement [49]:

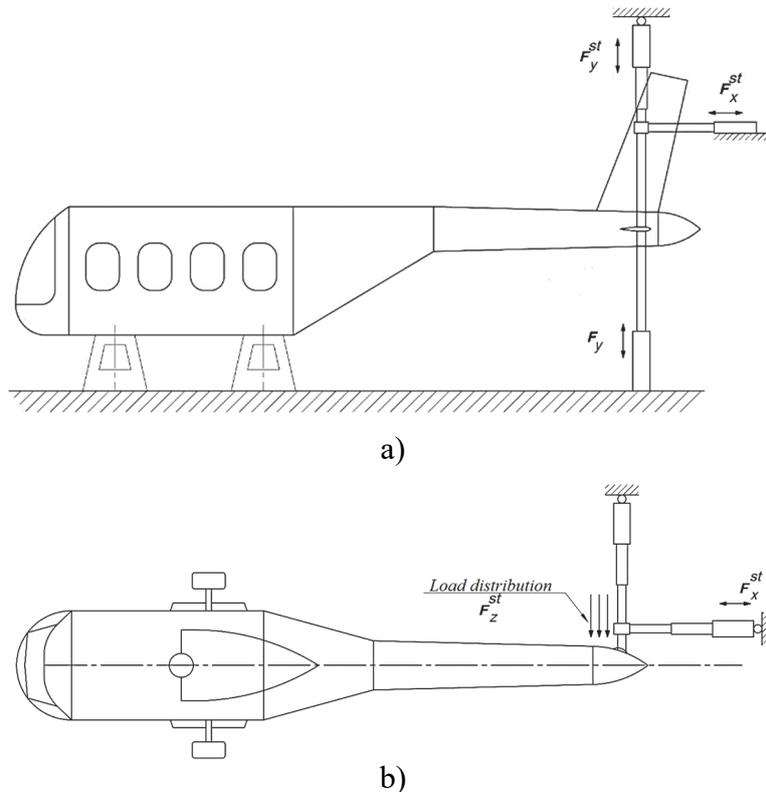
Test bench [91] is attached to the strengthened floor, using the chassis power structures (Fig. 2.6).

Fig. 2.6. Helicopter structure fatigue test bench:

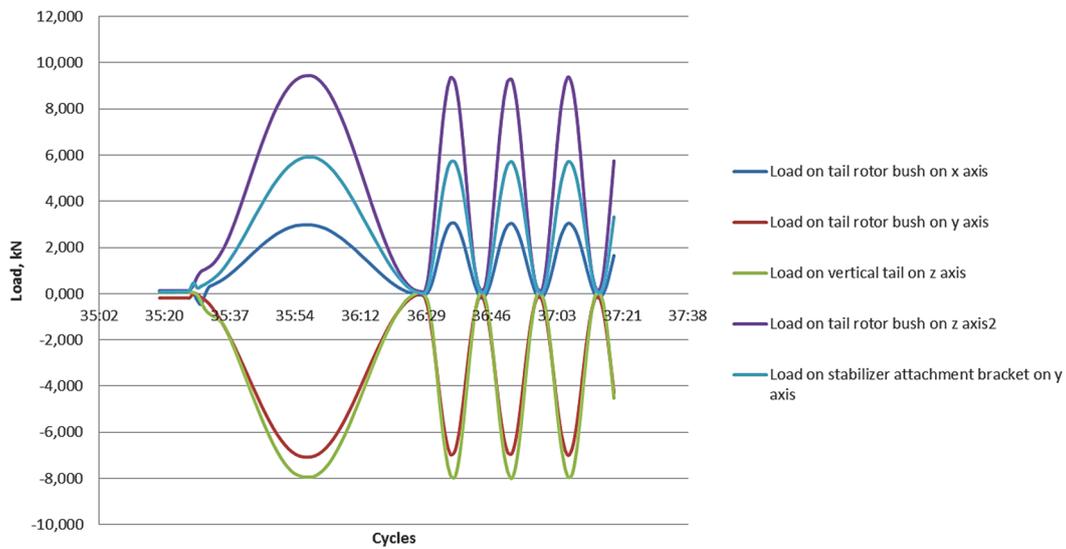
Test bench is equipped with a special system that allows applying the static load (Fig. 2.7.).

Fig. 2.7. Applied load for a helicopter's structure in time. Start cycle – 60 seconds; ordinary cycle – 15 seconds.

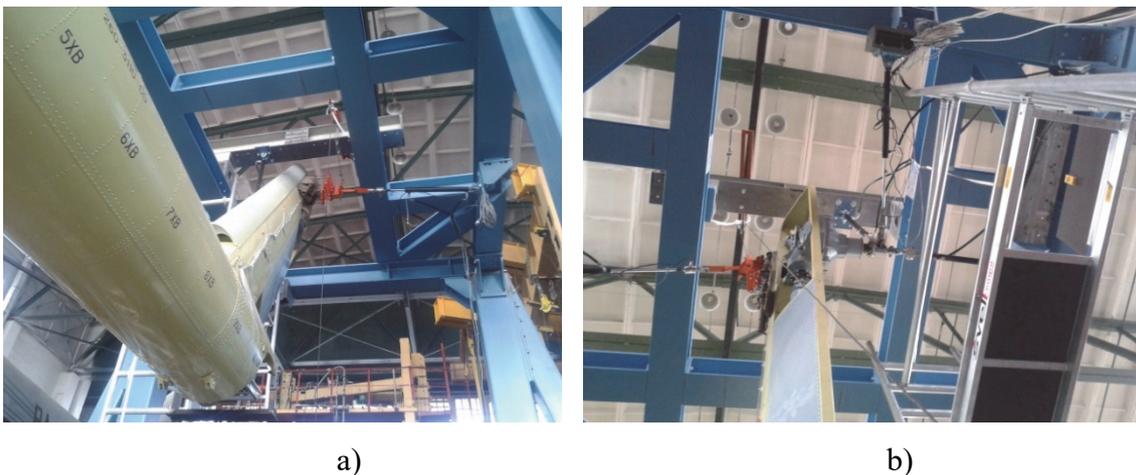
The tests are performed sequentially re-adjusting the static load in order that object stress-strain state complies with the established flight test time (air-ground-air). Maximum flight time loads were recorded at the maximum take-off weight. The load is applied at the hub of helm rotor – F_x^H F_y^H F_z^H , at the fastening points of the stabilizer – F_y as in Fig. 2.8.

Fig. 2.8. Applied distribution load on the keel for real construction [91]:
a) view against the flying direction from the left side; b) view in the flying direction from the left side.

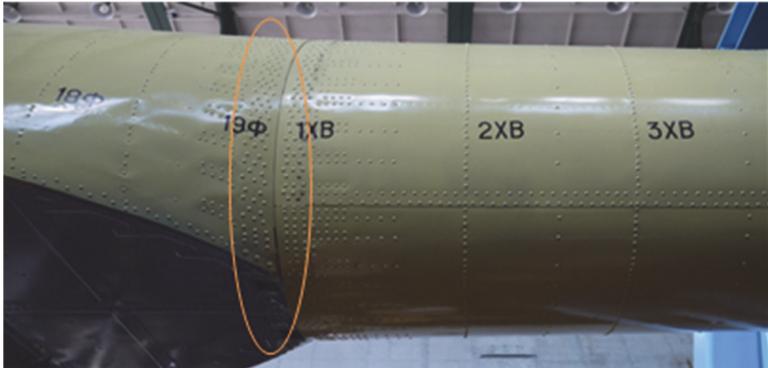
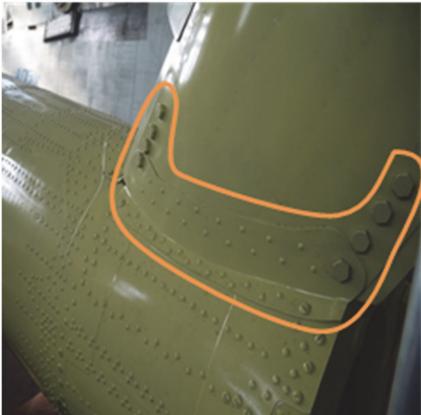
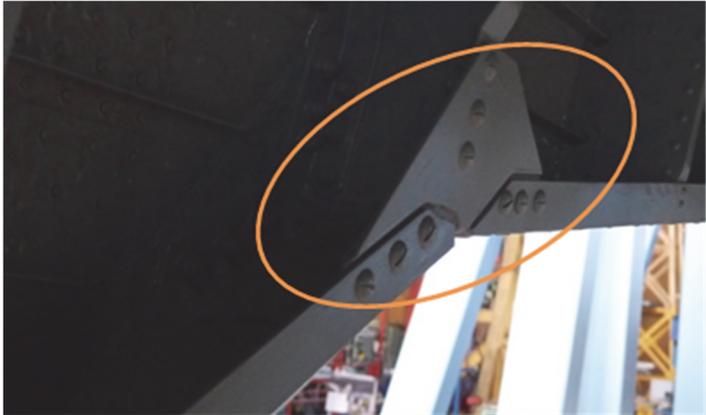
- a) joint area of the sloping frame No. 13 (Fig. 2.9.c);
- b) joint of tail boom and central fuselage part (Fig. 2.9.a);
- c) joint of tail boom and keel (Fig. 2.9.b).

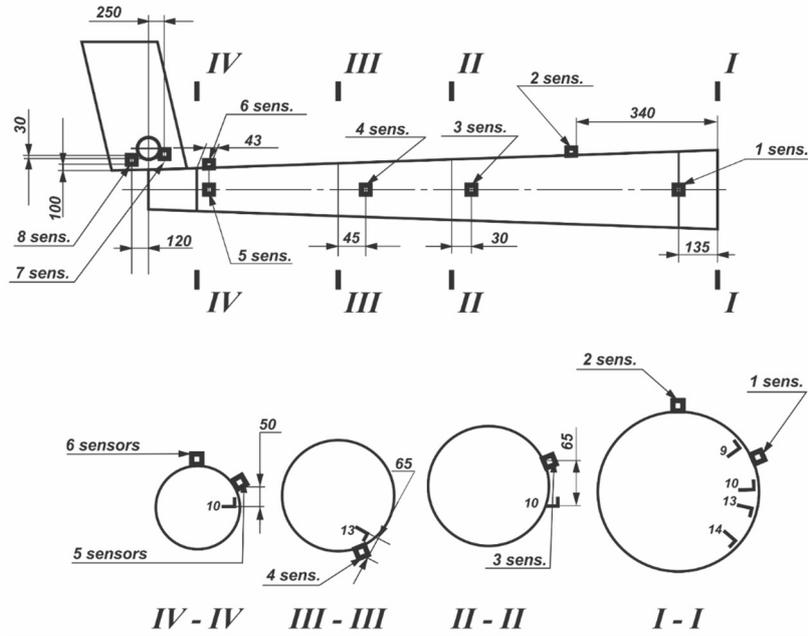
Fig. 2.10. Location of AE sensors on tail boom and keel [55, 57, 59, 62].

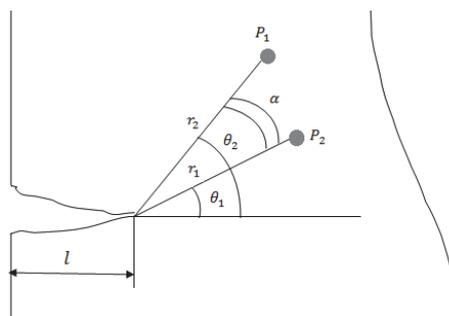
Fig. 3.1. Acoustic emission direction during crack growth [58].

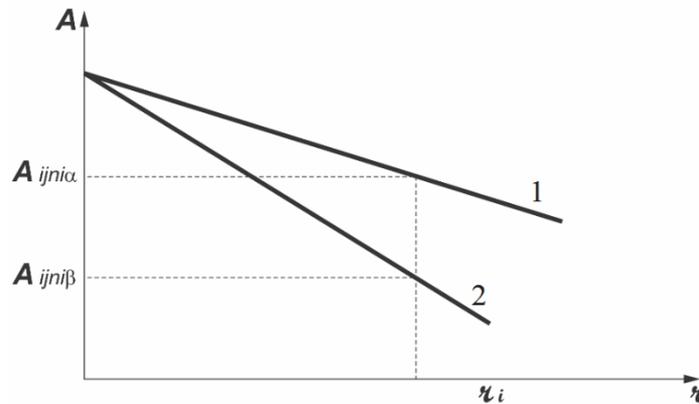
Taking into account the AE signal amplitude threshold, the limited signal propagation radius and the limited step of AE changes for real construction diagnostics, the following can be considered: in research areas, AE signal amplitude attenuation has linear character (Fig. 3.2), where angle α describes the slope of the AE signal attenuation curve.

Fig. 3.2. Linear approximate curve of AE signal attenuation.

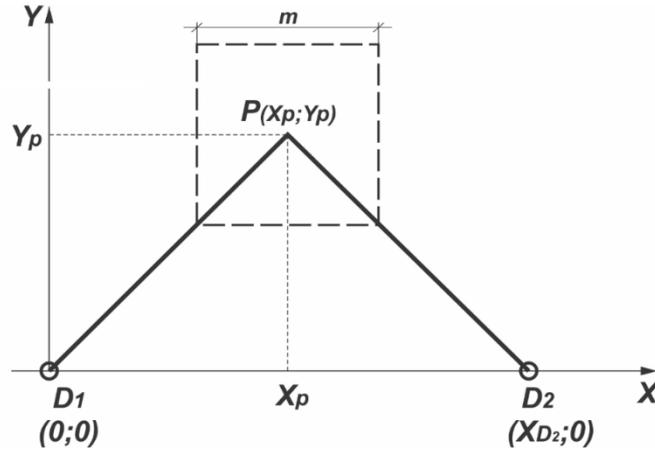
Fig. 3.3. AE source location in cluster with P as a centre.

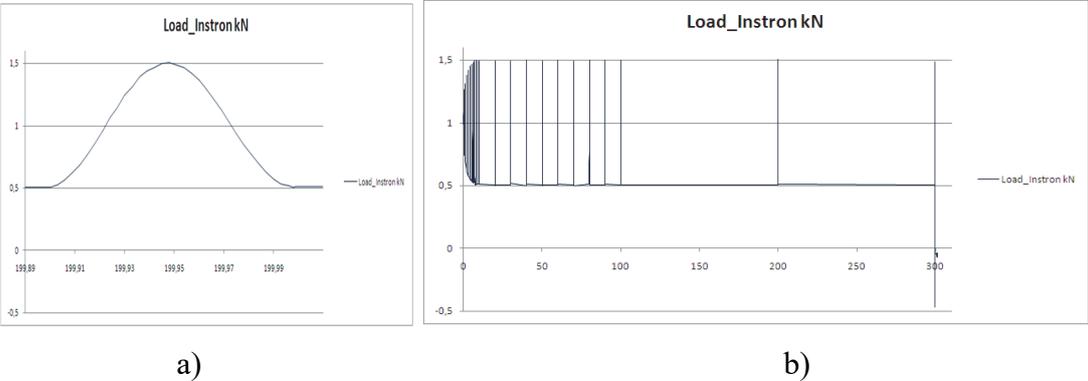
During the dynamic loading test, five samples were used. For the sample No. 2, one loading cycle lasted 0.10 seconds (Fig. 4.1.a), which in total constituted 299 seconds (Fig. 4.1.b), with the variable load from 0.5 kN to 1.5 kN.

Fig. 4.1. Applied loads for the sample No. 2:
 a – in one load cycle; b – during the entire test.

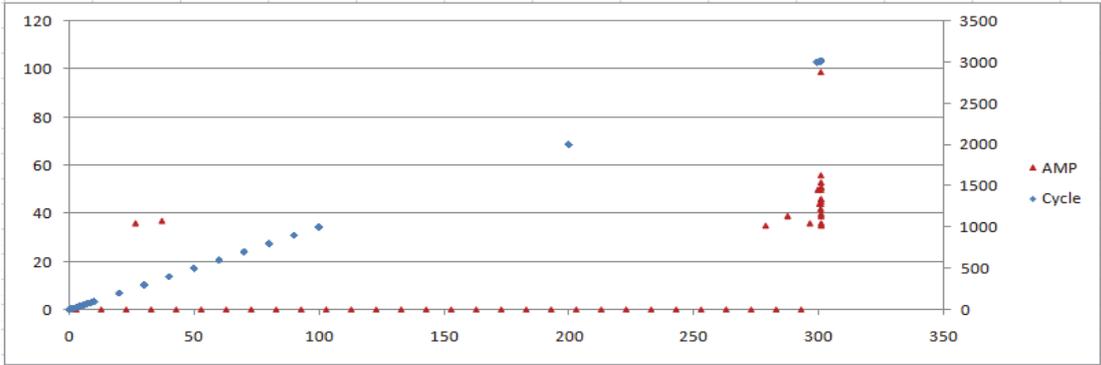
Such AE signal characteristics as sum count amplitude (Fig. 4.2) and energy reflect the full cycle of all loading. The AE amplitude clearly reflects the collapse moment of the material, when the AE signal amplitude reaches the maximum value from 90 dB to 100 dB, which is characterized by the collapse in the immediate vicinity of the sensor and is obtained from the experiment where samples were loaded with a static load.

Fig. 4.2. Dependence of the AE signal amplitude on time for the sample No. 2.

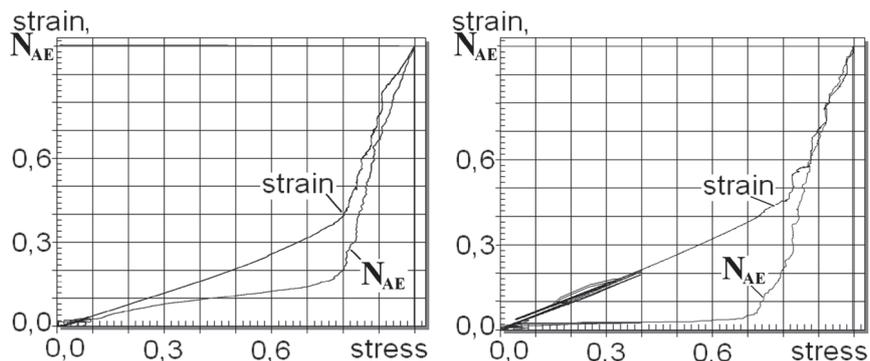
The results are displayed in graphs, where tension and AE parameter – total AE – are compared. The results are obtained under static loading, when tensioned transverse sample had no pre-training (Fig. 4.3.a) [49, 50].

Fig. 4.3. Dependence of the cumulative AE and deformation on the stress-strain of a sample with transverse fibers [49, 50]:

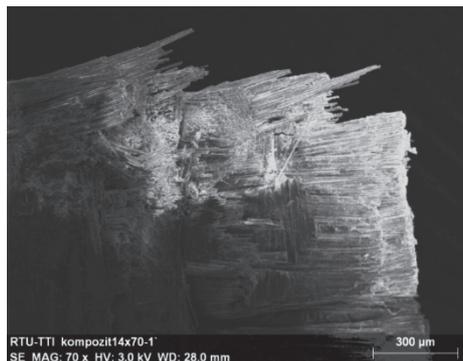
The character of a composite material sample with longitudinal fibre orientation is shown in Fig. 4.4.

Fig. 4.4. Fragment of a composite material sample with a longitudinal-orientation fracture [49, 50].

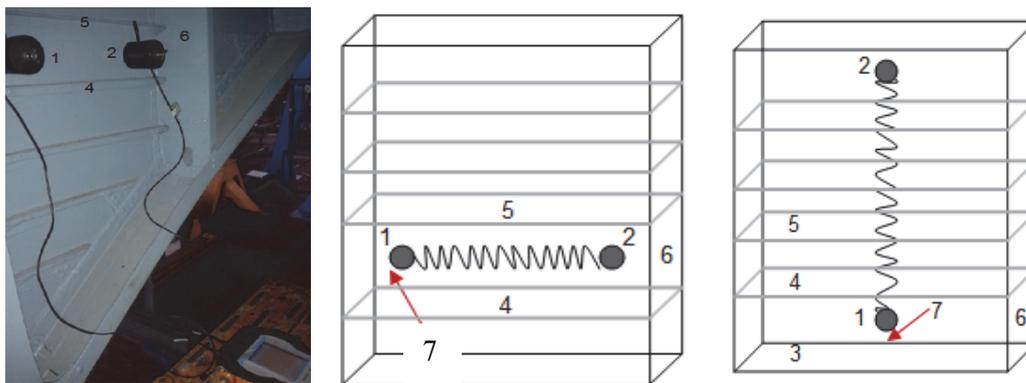
AE signal amplitude evaluation and signal propagation speed measurements have been made on helicopter skin taking into account such parameters as stringers, frames, and riveted and glued joint influence (Fig. 5.1.a, b) [58, 60].

Fig. 5.1. AE sensor displacement on the fuselage for the sound velocity and amplitude attenuation research:

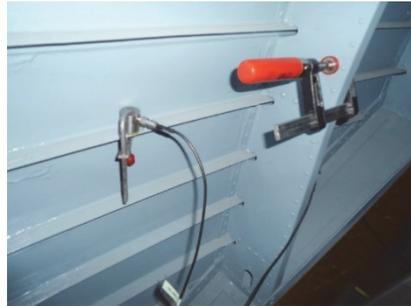
In order to create the attenuation card for AE signal amplitude in helicopter fuselage, experiments [60] were performed inside the fuselage taking into account the frame – stringers and frames. Four AE sensors were used in the experiment – one sensor was placed on the stringer No. 6 between frames No. 9 and No. 10; one sensor was placed on the stringer No. 10 between frames No. 6 and No. 7; the third and fourth sensor were placed on the fuselage between stringers No. 7 and No. 8 and frames No. 9 and No. 10, from inside and outside respectively.

Fig. 5.2. Location of AE sensors on helicopter fuselage.

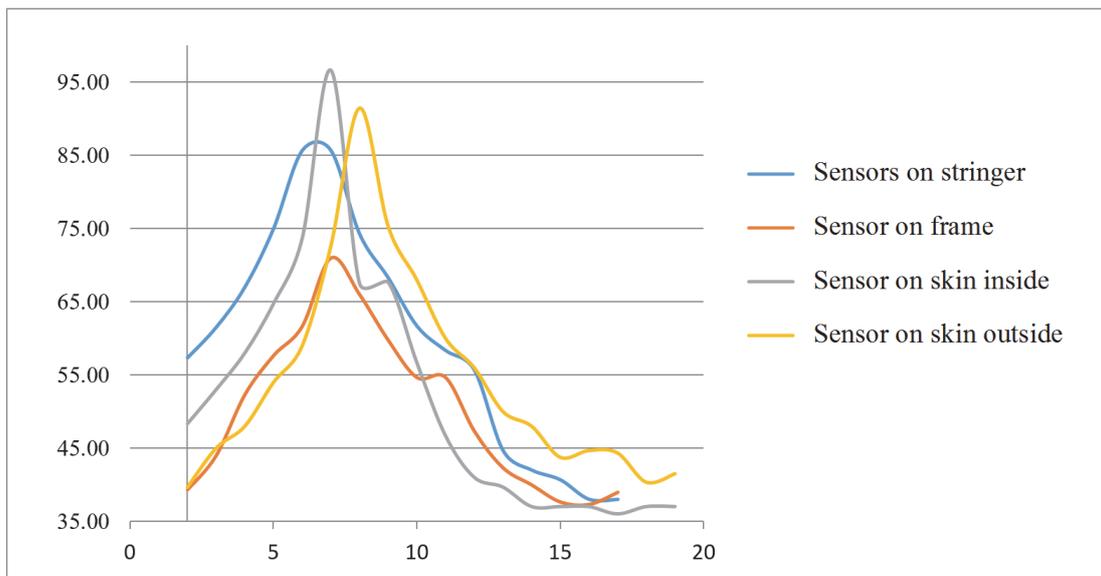
During imitating AE signal on the fuselage between frames No. 9 and No. 10, the arrival of signals was registered on all four sensors (Figs 5.3 and 5.4). Highest amplitudes were registered in close proximity of the respective sensors. In overall, lowest amplitudes were noticed on sensors that were placed on the frames. All sensors registered the signals initiated by stringers No. 16 and No. 17, and their amplitude level was above the set threshold of 35 dB [60].

Fig. 5.3. Imitated AE signal amplitude, dB (y axis) on stringers Nos 1–22 (x axis) between frames No. 9 and No. 10.

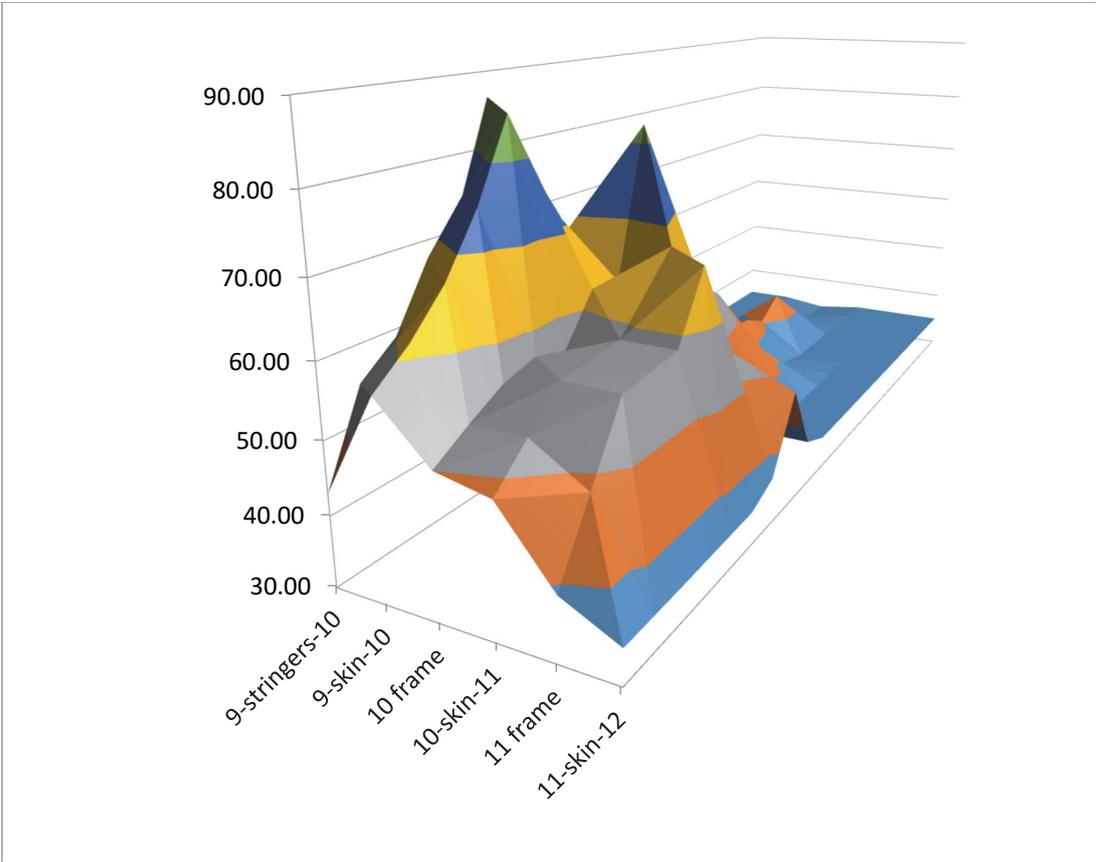
The charts of AE signal amplitude attenuation were created after summarizing the signal receiving amplitudes (Fig. 5.4). They illustrate the registered AE signal amplitude from the source located in a particular distance; besides, the amplitudes only above the 35-dB threshold were taken into account [60].

Fig. 5.4. Registration of AE signal amplitude on the sensors placed on stringers.

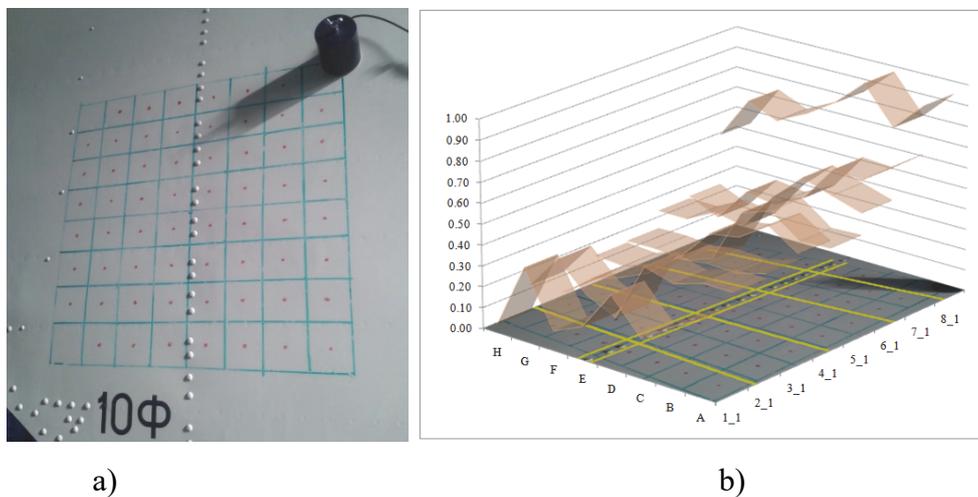
An AE sensor was placed in each of the corners of the square (Fig. 5.5.a). The signal was imitated 8 to 10 times in the middle of each small square. The results are summarized in a graphic form (Fig. 5.5.b). The relative error is obtained, and the average value of the compiled data is 0.86% to 0.90%.

Fig. 5.5. AE signal imitation quadrate:

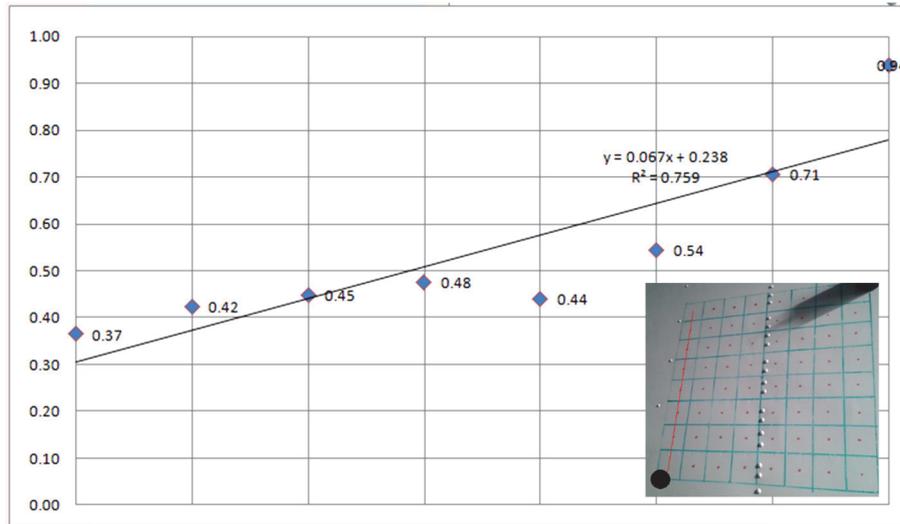
Fig. 5.6. Values of AE signal amplitude (y axis) in squares No. A1 to No. A8 (x axis).

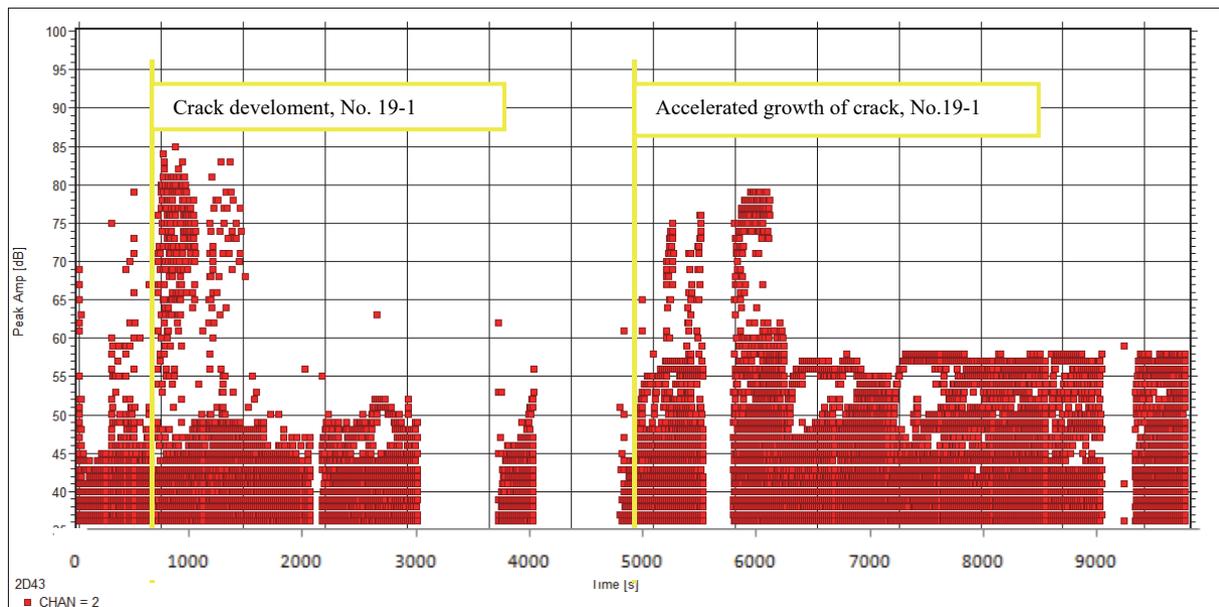
On the basis of analysis of AE parameters recorded in the process of testing [55, 57, 59, 62], the following was revealed. The AE signal amplitude (Fig. 5.7) recorded for all channels quantitatively reflects the process of failure. The value of amplitude depends on the point of AE sensor installation including its orientation relative to the source of AE signal and the distance to the source. The energy of AE signals (Fig. 5.8) is also an informative parameter for the diagnostics of large structures; this parameter quantitatively reflects the stages of the process of accelerated crack growth in the material of helicopter structural components. Due to significant influence of mechanical noises during the tests, total AE is only informative in the case of additional filtration. This process is rather time-consuming and requires the development and application of a special program for the processing of recorded signals.

Fig. 5.7. The amplitude of AE signals, and dB (y axis) recorded in the interval of 1-9812 load cycles (x axis).

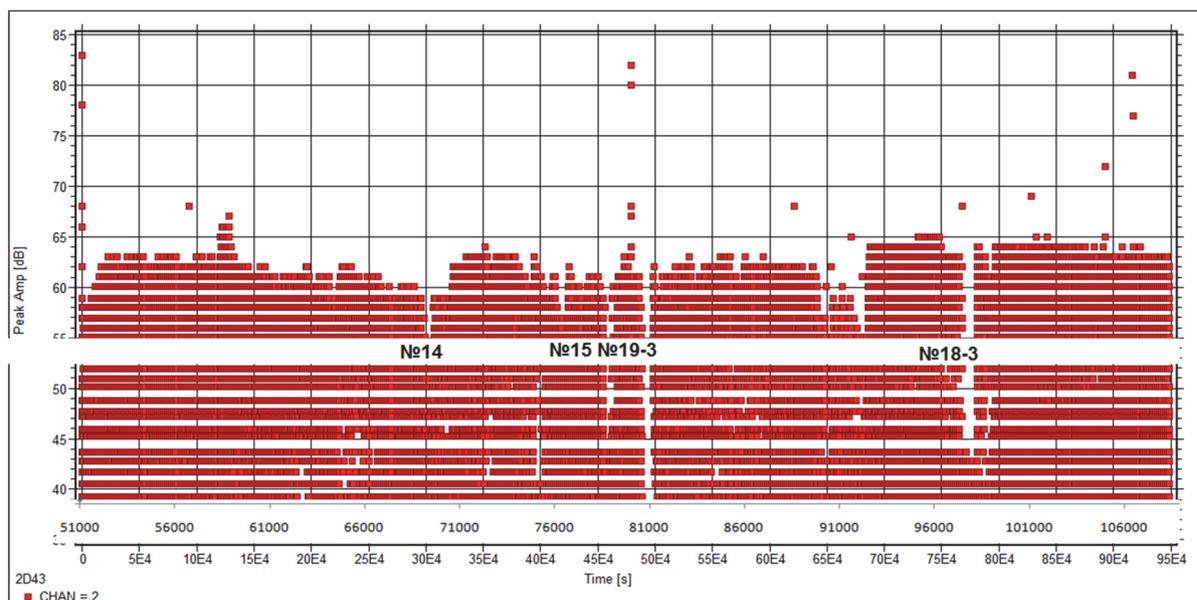
Fig. 5.8. The amplitude of AE signals, and dB (y axis) recorded in the interval of 51000-108958 load cycles (x axis).

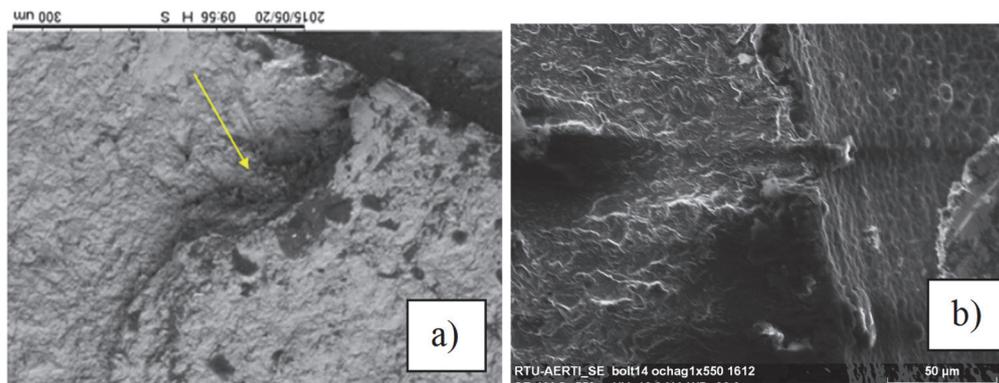
Fig. 5.9. Nucleus area: a) No. 19; b) No. 14.

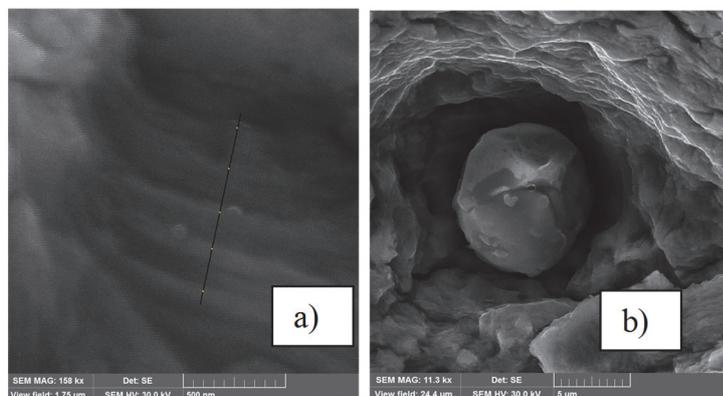
Fig. 5.10. Bolt No. 19-1: a) fatigue mesoline, $h = 0.15\text{--}0.17\ \mu\text{m}$; b) inclusion.

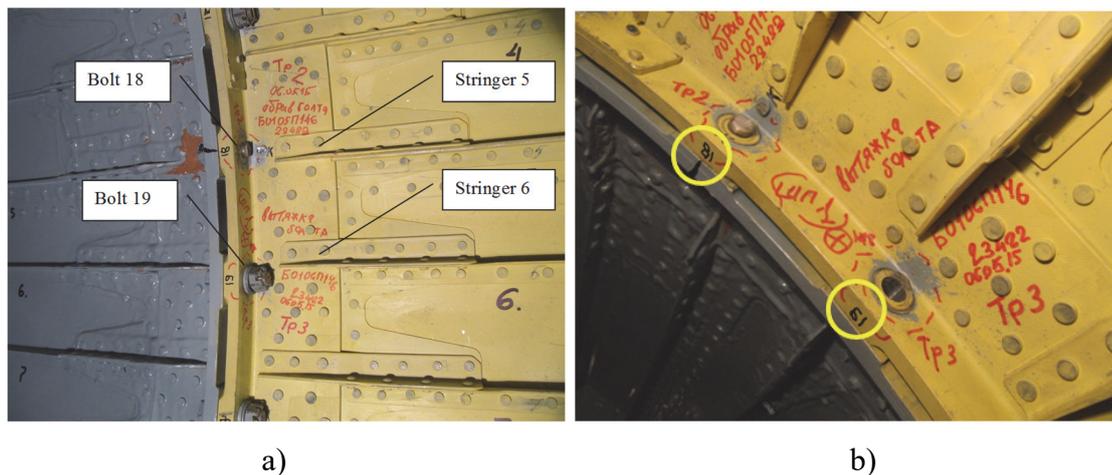
On the basis of AE monitoring data, in the process of inspection of 23022 load cycles, it was found that attachment bolts No. 19-1 and No. 18-1 in the area of stringers 5 and 6 along the right side had failed (Fig. 5.11).

Fig. 5.11. General view of the failed bolts No. 19-1 and No. 18-1:

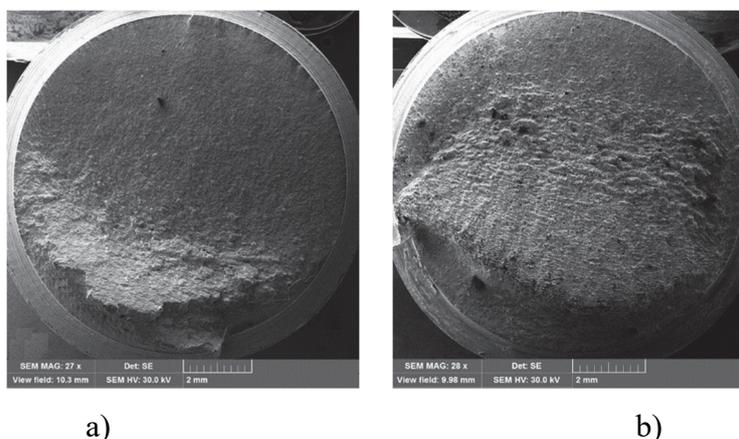
The fractures of both bolts have a fatigue nature (Fig. 5.12).

Fig. 5.12. Fatigue fractures of bolts:

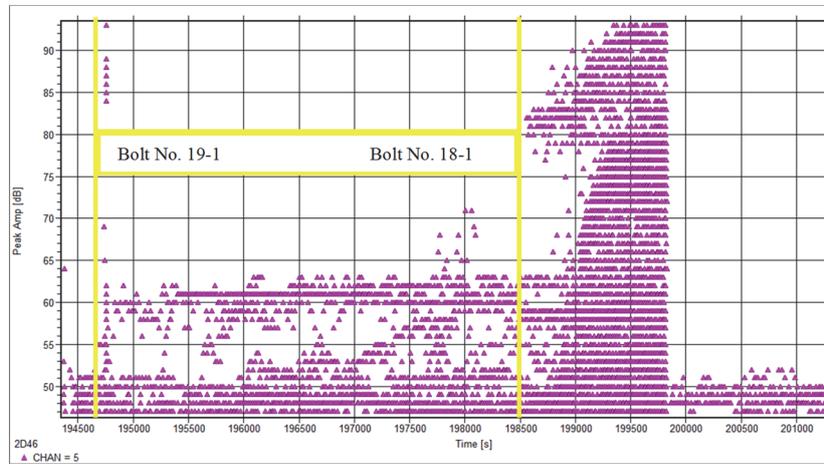
curves of AE parameter records reveals the presence of several more nuclei of fatigue damage, in particular, accelerated fatigue crack growth was detected in the interval from 15400...15600 to 17600...17800 load cycles, which probably reflects the kinetics of fatigue crack propagation in the material of bolt No. 18-1 (Fig. 5.13).

Fig. 5.13. Time-dependent behaviour of AE signal amplitude, dB (y axis) from 9812 load cycles to the failure, bolts No. 18-1 and No. 19-1 (x axis).

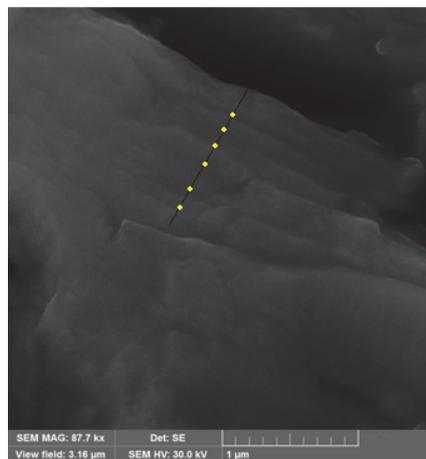
According to the results of our fractographic examination, in the case of bolt No. 19, the crack growth rate at the initial stage of destruction was on average $0.08\text{--}0.09\ \mu\text{m}/\text{cycle}$. This regularity was being observed until the crack reached a length of approx. $260\ \mu\text{m}$, which corresponds to 3000...4000 load cycles. Then the changes in crack growth rate were detected at the levels of $0.15\ \mu\text{m}/\text{cycle}$ and $0.25\text{--}0.35\ \mu\text{m}/\text{cycle}$ (Fig. 5.14). The specified rate was being observed up to the bolt failure at approx. 18000...19000 load cycles. The propagation of the crack in the material of bolt No. 18 also occurred with an average rate of $0.25\text{--}0.35\ \mu\text{m}/\text{cycle}$, which corresponds to approx. 6000...7000 load cycles. In the area of accelerated crack growth, it is possible to observe some characteristic zones of sliding.

Fig. 5.14. Fatigue mesolines, $h = 0.11\text{--}0.16\ \mu\text{m}$, bolt No. 19.

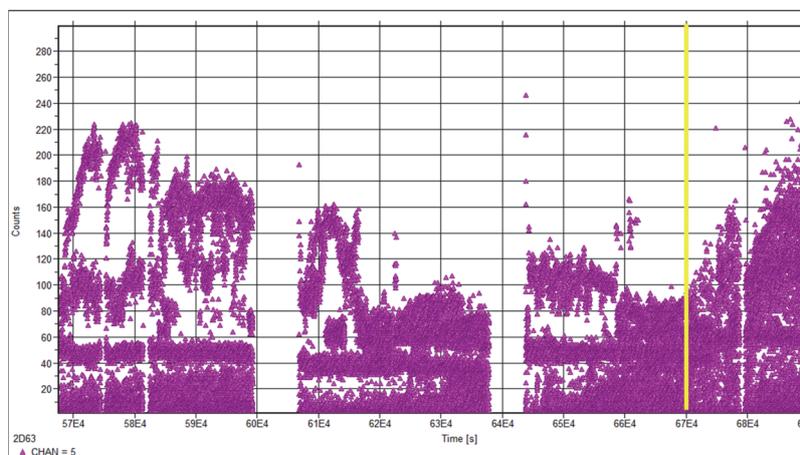
The tests were continued after the replacement of failed attachment bolts No. 18-1 and No. 19-1 in the area of stringers 5 and 6 along the right side of the tail boom in 23022 load cycles with new bolts numbered 18-2 and 19-2 respectively. The tests were accompanied by continuous recording of AE signals on all selected channels up to 51000 load cycles when during a regular inspection a repeated failure of bolts 18 and 19 was revealed. The total operating time of bolts from the moment of their installation to their complete failure was 27978 cycles. On the basis of AE measurements, which are common for both bolts, the accelerated growth of fatigue cracks was detected at 46600–47000 load cycles (Fig. 5.15).

Fig. 5.15. Time-dependent behaviour of the AE signal intensity.

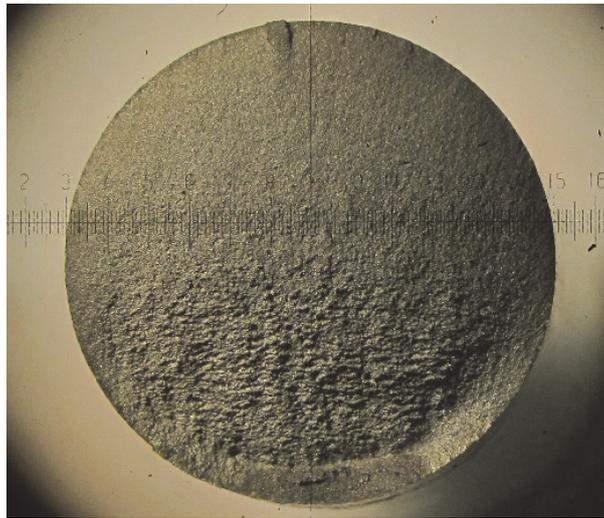
After the completion of another stage of tests in 80 615 load cycles, the inspection helped to reveal the 3rd (during the tests) failure of the attachment bolt for the hole No. 19 in the area of stringer 6 along the right side. The fracture (Fig. 5.16) has a fatigue nature typical for all the previously failed attachment bolts. The fatigue zone occupies about 95% of its area and consists of a fine-grained site (more than 60% of fracture area) and a coarse-grained site.

Fig. 5.16. Fracture of bolt No. 19-3 on the bolt shank.

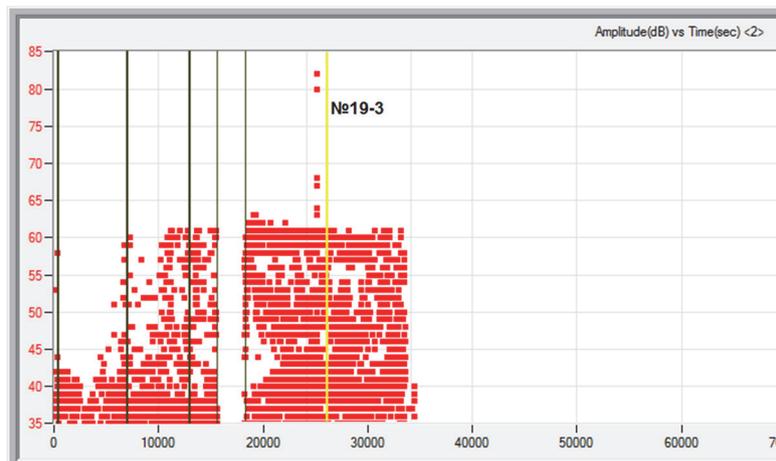
The failure of bolt No. 19-3 was detected by all the AE sensors installed in the area of tail boom and fuselage joint. The failure of this bolt is characterized by AE signals with an amplitude increasing up to 80...85 dB (Fig. 5.17.) at the 80050...80100 load cycle. At the same time, the accelerated growth of the crack in the bolt material was detected after reaching the 78800...78900 load cycle when AE signal amplitudes increased up to 60...62 dB. The accelerated growth of the crack was being observed during about 1250 cycles, i.e., in the case of applying the AE method during operation, the bolt failure could be predicted approx. 26 flying hours ahead.

Fig. 5.17. Time-dependent behaviour of AE signal amplitude (y axis) during the accelerated growth of the crack until the fracture, bolt No. 19-3.

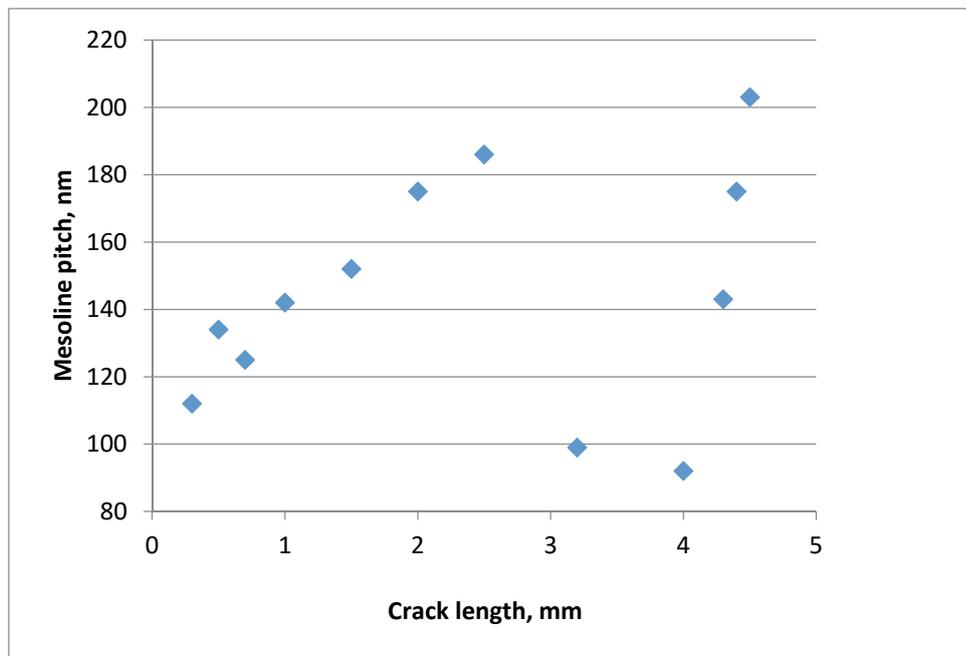
The subsequent 500 μm the crack was propagating at a rate of 125–142 nm/cycle. The length of the given site corresponds to 3759 load cycles. Then the next 2000 μm the crack was propagating during 12345 c at an average rate of 162 nm/cycle. The total life at this stage corresponds to 20169 load cycles. Then, on a radius of about 3000 μm from the nucleus the slower growth of the crack was observed (Fig. 5.18). This site corresponds to the moment of bolt retightening (twice) after the failure of bolts 14 and 15 in 69603 and 78601 load cycles respectively. The length of this site corresponded to 10 447 load cycles. Then, for approx. 1000–1500 μm , there continued a slower growth of the crack at a rate of 90–110 nm/cycle, which corresponds to 9197 load cycles.

Fig. 5.18. Dependence of fatigue striation increment on the length of the fatigue crack with account of retightening of bolts in the joint between the tail boom and fuselage, bolt No. 19-3.

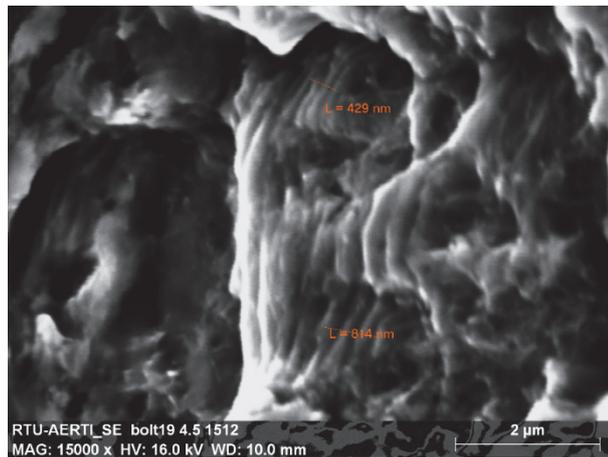
After that, the crack growth accelerated up to the rate of 200 nm/cycle. On a radius of about 4–4.5 mm (Fig. 5.19) from the nucleus area, the failure has a mixed nature reflecting the accelerated growth of the crack. The total life of the bolt material is 30 616 load cycles.

Fig. 5.19. Fatigue mesolines, $h = 143..203$ nm/cycle (4.5 mm from the nucleus).

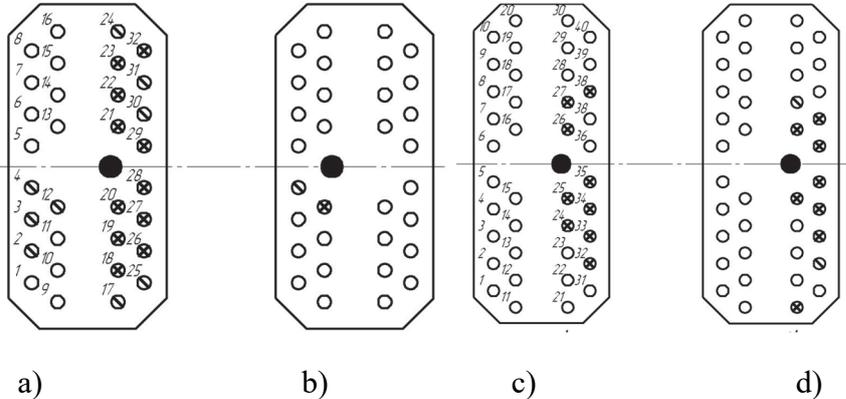
wear, a comparative evaluation of the condition of riveted connections in joints No. 3 and No. 6 in plates 6, 7 and 8 was carried out. The pulsar was sequentially placed on plates 6, 7 and 8, while the AE sensor was used to respectively receive the signal from the head of each rivet. Fig. 5.20 represents the diagrams containing the numbering of the rivets being monitored and the results of the tests [8, 40].

Fig. 5.20. Diagrams of rivet numbering, and results of testing the bottom of the joints No. 3R and No. 6R in various connections:

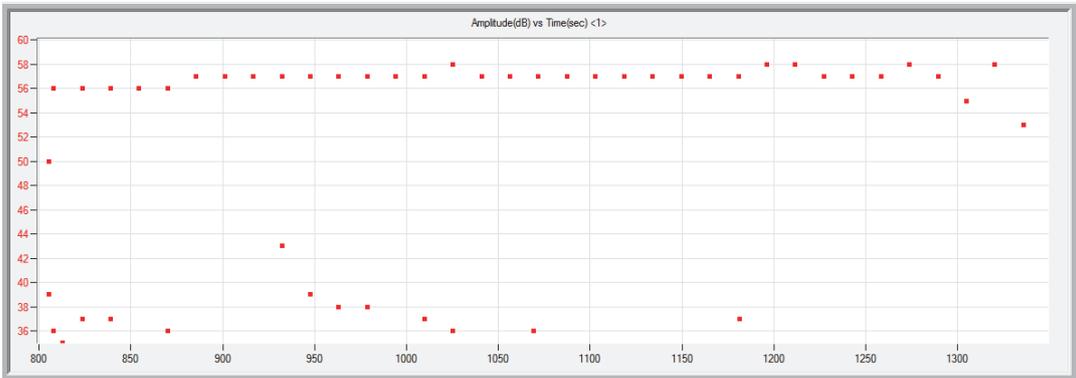
When the pulsar was installed on plate 6, the steady signal was received from the rivets Nos 18 (Fig. 6), 19, 20, 21, 22, 23, 26, 27, 28, 29, 32 (Fig. 5.21); the unstable signal was received from the rivets Nos 2, 3, 4, 12 (Fig. 7), 17, 24, 25, 30, 31; no signal was detected on the rest of the rivets (i.e., the AE signal was received from approx. 47% of the total number of rivets). The general evaluation of the condition of the riveted connections for the connection (a) (see Fig. 5.20.a): 47% of the total numbers of rivets in the connection are found to be suitable for further use.

Fig. 5.21. Time-dependent steady AE signal with an amplitude of approx. 57 dB (y axis) received from the rivet No. 18.

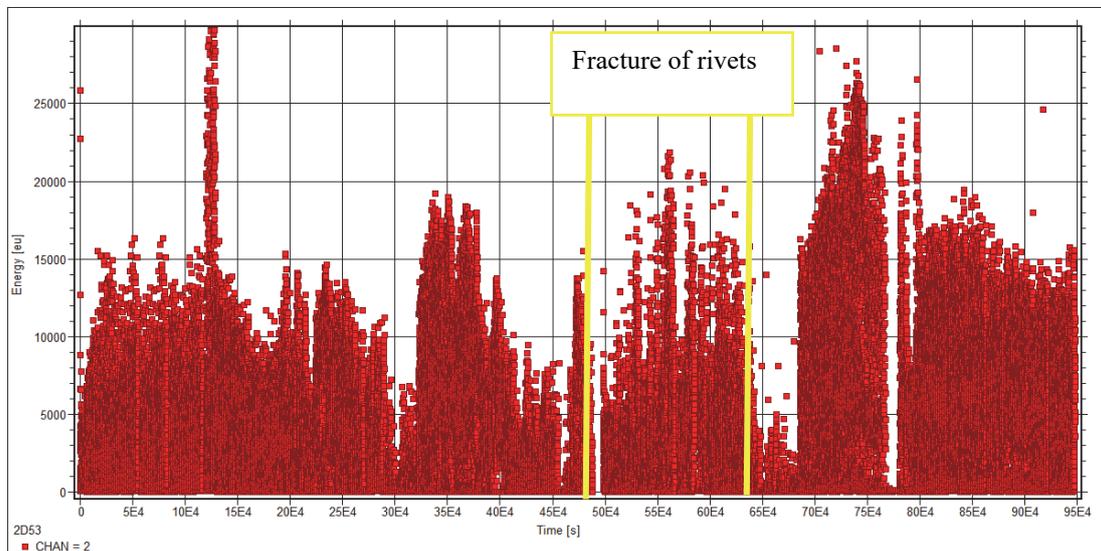
Besides controlling the bolt connections in the trials of helicopter structure resources, one of the tasks was also the evaluation of the defects of constructive node elements and compounds, including riveted connections. During testing of helicopter structure resources at the loading cycles 91 203...92 175, the change in the AE signal informative parameters, such as energy and cumulative energy (Fig. 5.22), indicated the presence of damage in the area of the left side frame No. 9 of the fuselage. In the research, second registration channel of the AE sensor was also informative. It was mounted on the helicopter fuselage and tail beam joint frame No. 1. The most considerable changes in energy and summar energy were fixed at 92 175 loading cycles.

Fig. 5.22. Time-dependent changes in the AE signal energy (y axis), characterizing the defects of the rivets in joints.
