RIGA TECHNICAL UNIVERSITY
Faculty of Mechanical Engineering, Transport and Aeronautics
Institute of Aeronautics

**HELICOPTER STRUCTURE FATIGUE DEFECT
ACOUSTIC DIAGNOSTICS WITH DEFECT LOCALIZATION**

Summary of the Doctoral Thesis

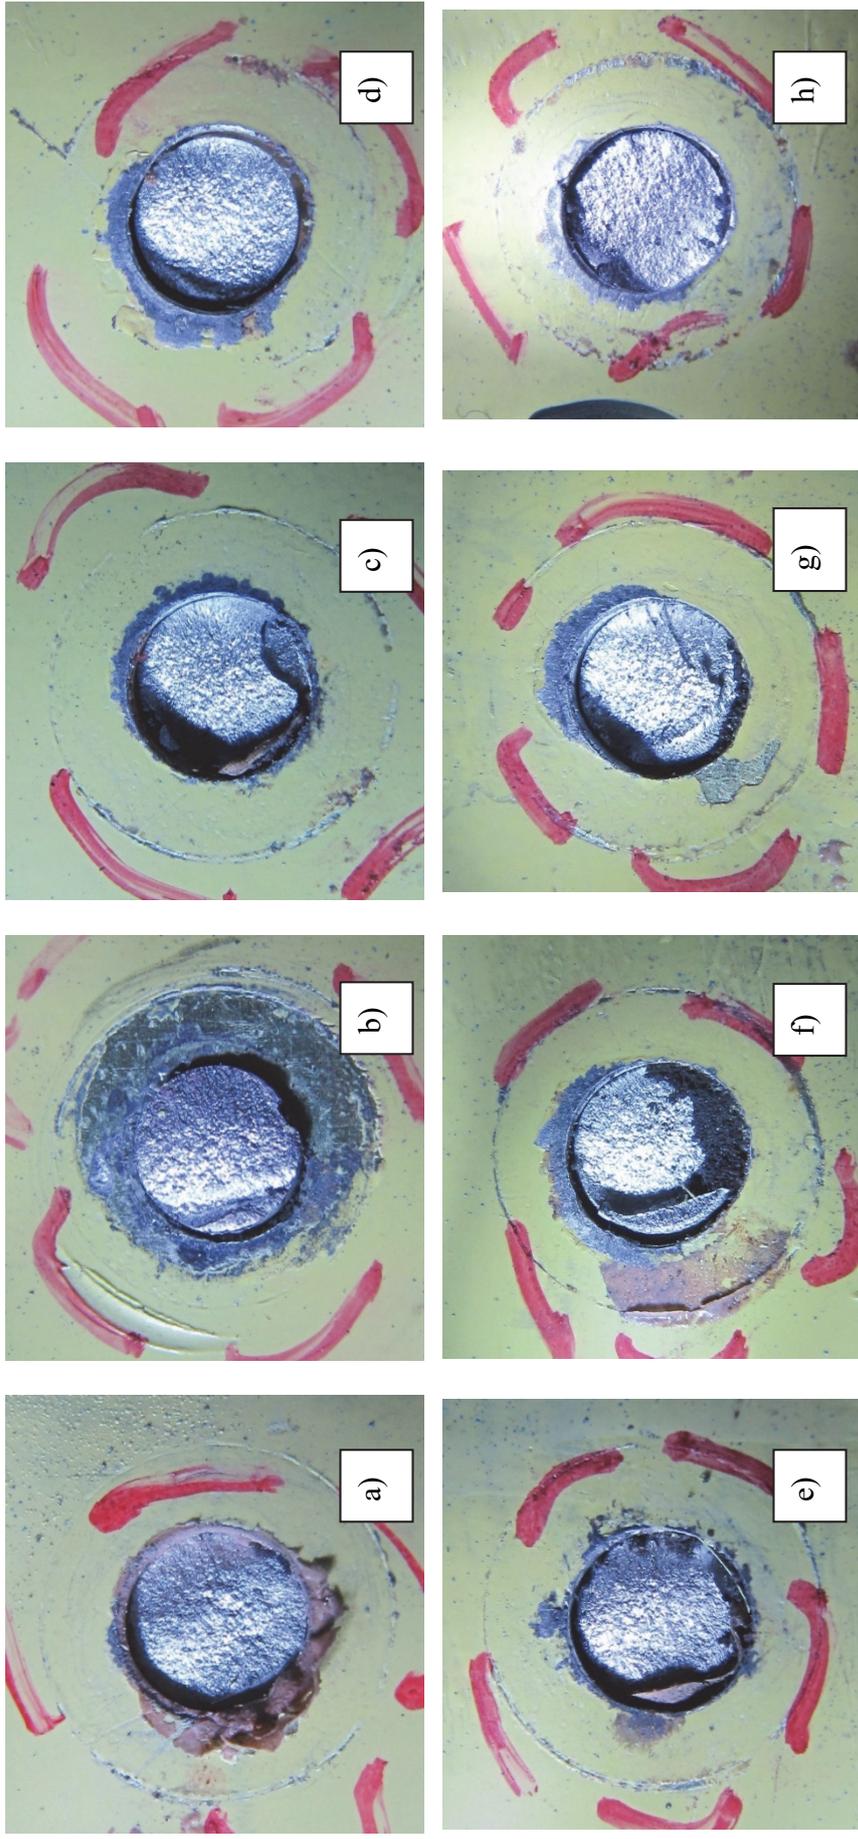
During subsequent investigation, the raised AE signal source was identified – collapse of two rivets along the fuselage No. 9 on the left board in the area of stringers Nos 26 and 27 was found during regular inspection of the helicopter structure at the 91203 load cycle. They are marked accordingly, as crack No. 16 and No. 17. In the subsequent loading process at the load cycle 92175, six adjacent rivet collapses were recorded. The defects were labeled as cracks Nos 19–23. Fig. 5.23 depicts all the collapsed rivet fractures.

Fig. 5.23. Overview of the rivet material cracks after their collapse:
