**AVIĀCIJAS ALUMĪNIJA SAKAUSĒJUMU
KONSTRUKCIJU ELEMENTU TEHNISKĀ STĀVOKĻA INTEGRĒTĀ
KONTROLE AR
PJEZOELEKTRISKIEM SENSORIEM**

**HEALTH MONITORING OF
ALUMINUM AIRCRAFT STRUCTURAL ELEMENTS USING
PIEZOELECTRIC SENSORS**

**Promocijas darba kopsavilkums
Summary of Doctoral Thesis**

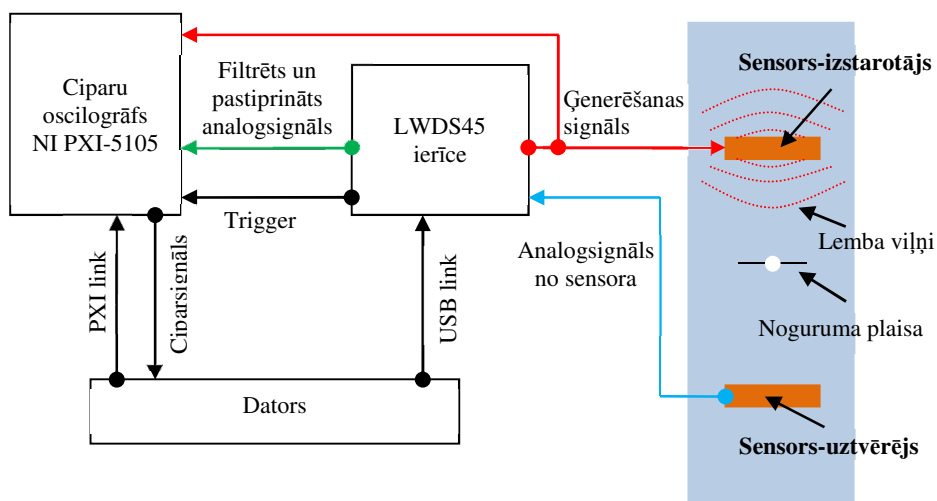
4. att. Lemba viļņu un noguruma plaisas mijiedarbības eksperimenta shēma

Ultraskaņas viļņu ģenerācijai un uztveršanai tika izmantotas sekojošas ierīces: specializēta ierīce LWDS45 Cedrat Technologies, kas ietver signālu pjezoelektrisko sensoru ierosināšanas ģeneratoru un signālu uztveršanas moduli. Signālu uztveršanas modulis iekļauj sevī augstfrekvenču filtru un pastiprinātāju. Sensora signālu reģistrācijai tika izmantots oscilogrāfs National Instruments PXI-5105, kas tika savienots ar LWDS45 ierīci. Ierīču darbību kontrolēja dators ar programmatūru. Eksperimentā mērīšanas shēma ir dota 4. attēlā.

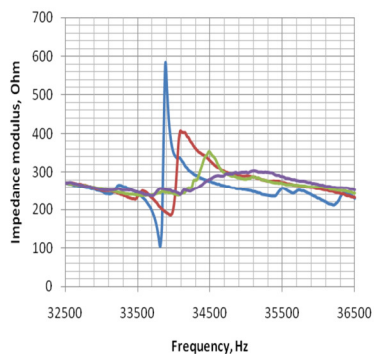
10. att. Sensora rezonanse pie lokāla stinguma palielināšanas

Stinguma variācija maina rezonanses frekvences un amplitūdas, kā redzams 10. un 11. attēlā. Attēlos parādīta pirmās rezonanses josla 32.5-36.5kHz. Minētās joslas rezonanses frekvences atkarība no bojājuma garuma ir piedāvāta 12. attēlā. Var redzēt, ka ir izteikta, gandrīz lineāra sakarība starp bojājuma lielumu un rezonanses frekvenci.

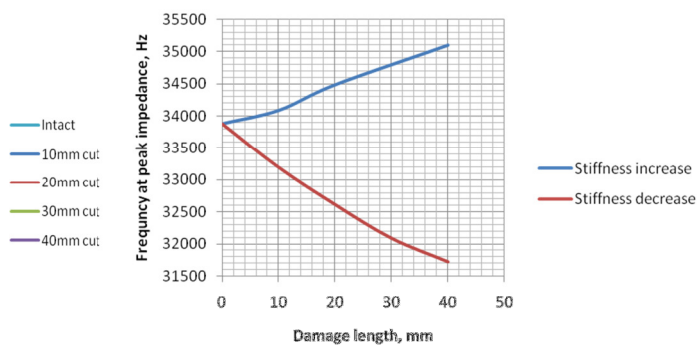
12. att. Lokāla stinguma izmaiņas ietekme uz sensora pirmās rezonanses frekvences vērtību.

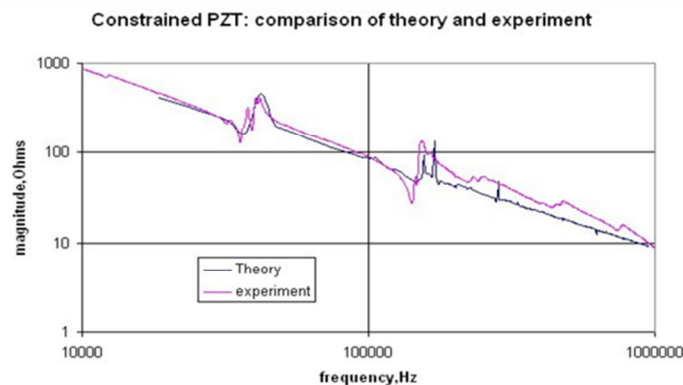
14.att Piezokeramiska sensora impedances raksturlīknes : aprēķināta (theory) un eksperimentāli iegūta (experiment)

Elektromehāniskās impedances aprēķina rezultāti, izmantojot modeli, un eksperimentālie rezultāti ir salīdzināti 14. attēlā.

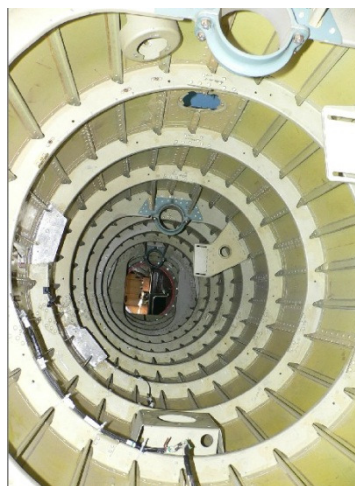
16. att. Astes sijas skats no iekšpuses

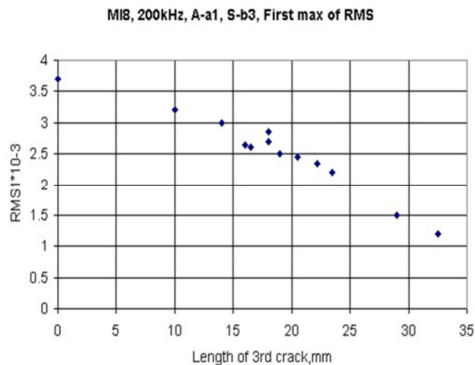
21. att. Uztvērēja B3 signāla intensitātes atkarība no #3 plaisas garuma

Signāla intensitātes parametra $RMS(t)$ maksimālā vērtība atkarībā no plaisas bojājuma garuma uztvērējam B3 ir dota 21. attēlā. Dotajā gadījumā, plaisas garumam palielinoties, tiek bloķēts viļņu izplatīšanās ceļš starp izstarotāju un uztvērēju, tādējādi samazinot uztvertā signāla intensitāti. Attēls parāda gandrīz lineāru uztvertā signāla intensitātes samazināšanos. Tomēr citas „izstarotājs - uztvērējs” kombinācijas var parādīt ne tik labi izteiktu korelāciju viļņu nelabvēlīgas interferences, atstarošanas un kniedētu savienojumu izraisītas viļņu izkliedes dēļ.

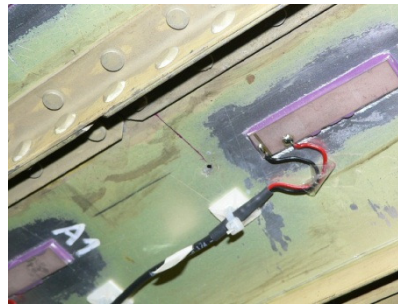
22. att. Plaisa #2 pēc 271600 cikliem

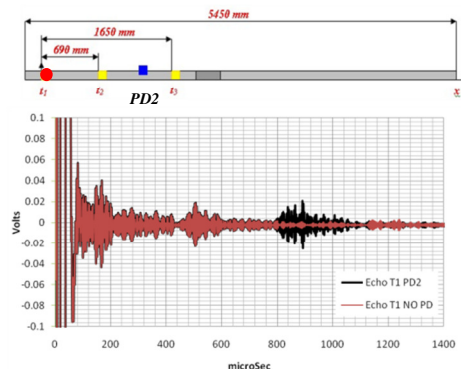
28. att. Atbalss signāli no izstarotāja T1. Pirms defekta (sarkans) un pēc pseido defekta PD2 ieviešanas $X=1170 \text{ mm}$ (melns)

Signāli iegūti ar atbalss (echo) un caurejošu (pitch-catch) metodēm ir daļēji uzrādīti 27-30. attēlos. Tiek imitētas trīs plaisas (sk. 26. att.).

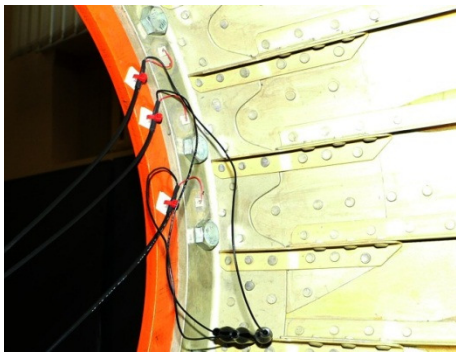
31. att. Trīs pjezoelektriskie sensori pielīmēti uz ribas #17 virsmas bultskrūves savienojumu pievilkšanas spēka zuduma monitoringam

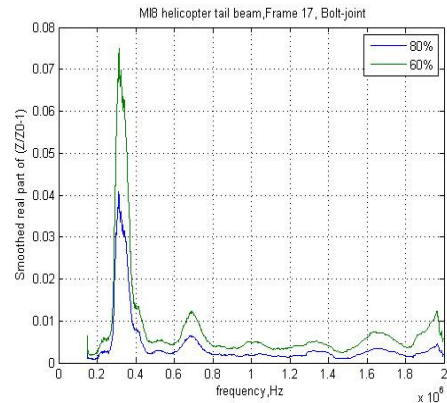
32. att. Impedances reālas daļas relatīvās izmaiņas nogludinātie grafiķi $S(f)$ divām skrūves pievilkšanas momentu vērtībām

Kā var redzēt, maksimālas deviācijas no nulles vērtības ir ap 7.5% un 4% un atrodas 200-400kHz frekvences diapazonā. Pastāv stabila izvēlēta parametra palielināšanas tendence bultskrūves pievilkšanas spēkam samazinoties.

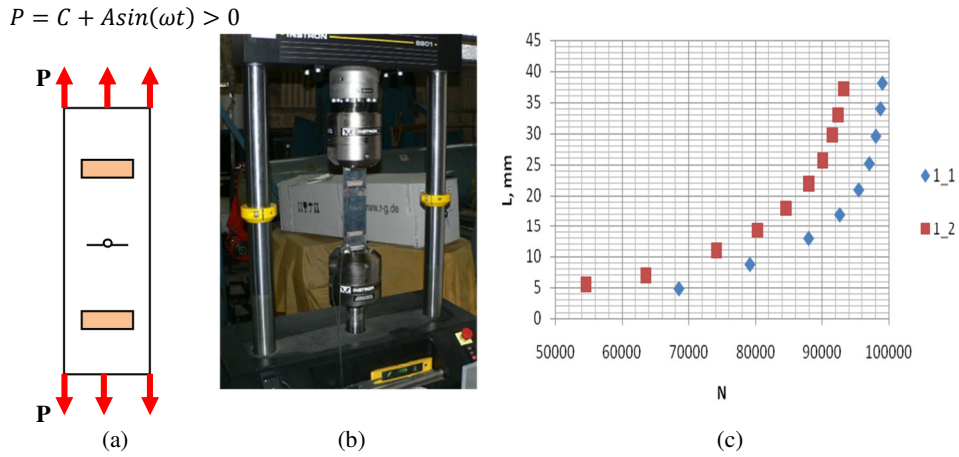
Figure 3 Test specimens loading configuration (a), a specimen installed in the universal testing machine Instron 8800 during experiment (b) and L-N curves obtained for a specimen (c)

Fatigue crack damage was initiated and grown in the specimens with the help of the universal servo-hydraulic testing machine Instron 8800 which was setup to produce harmonic cyclic tensile loading. The loading configuration and an example of obtained L-N curves are given in Figure 3. The onset position of the cracks in the specimens was reliably determined by the presence of stress concentrators in the form of a center hole or rivet joints. Crack propagation direction determined by the stress state was perpendicular to the tensile loading force P . The crack propagation was controlled visually using a tenfold magnification microscope.

Maximum crack size was limited with 40 mm. Every 2 mm of crack size increment the loading process was stopped and the monitoring experiment was performed as described below.

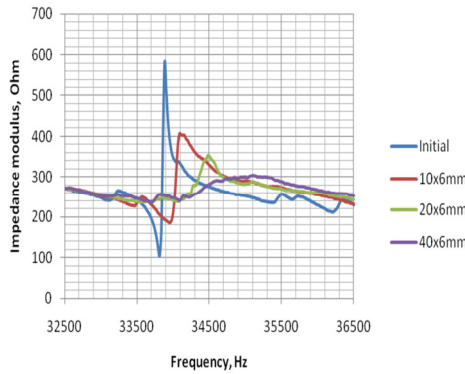
Figure 10 The first resonance of a constrained sensor (local stiffness increase)

Stiffness variation varies sensor impedance resonance frequencies and magnitudes as can be seen in Figure 10 and 11. In the pictures the first resonance band from 32500 to 36500 Hz is shown. For the chosen band the resonance frequency and the damage length relationship can be seen in Figure 12.

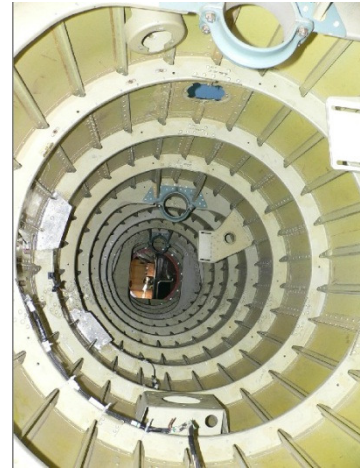
Figure 16 The inner view of the skeleton of MI-8 helicopter tail boom

The location of the tail boom in the structure of the helicopter is illustrated in Figure 15 with green color. The boom has the shape of the truncated cone with a length of 5485 mm. End frame diameters are 1000 and 550 mm respectively. The material of all main elements of the boom is D16T aluminum alloy in the Russian classification (2024-T3 in The International Alloy Designation System), with a skin thickness of 0.8 - 2 mm. The largest skin thickness of about 2 mm is found in the trailer part of the boom. The structural skeleton of the boom consists of 17 frames and 26 stringers and is shown in Figure 16.

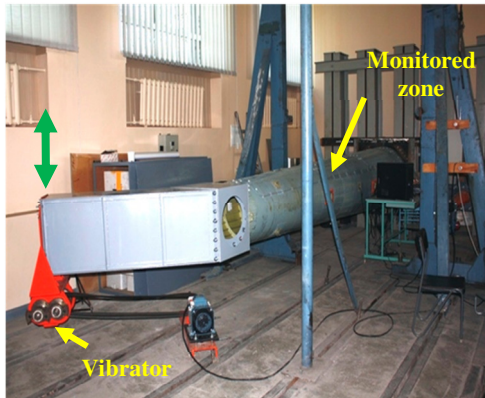
Figure 19 Mi-8 tail boom cyclic loading testing rig

A testing rig for tail boom dynamic loading was designed and built and is shown in Figure 19. The tail boom is fixed as a cantilever beam. A mechanical centrifugal force vibrator is attached on the free end of the tail boom able to generate harmonic vertical force of required amplitude and frequency.

The type of dynamic loading should ensure that the maximum possible level of stress is localized in the chosen zone for reliable crack initiation and further growth. On the other hand, the loading system should be as simple as possible and energy efficient. The preferable solution of this problem is the choice of a resonant way of loading at the one of the natural frequencies of the beam so that the maximal curvature of bending axis occurs in the zone of expected fatigue damage. The required conditions can be met when loading force frequency equals the second resonant frequency of the tail boom, which is around 60 Hz for the described test rig configuration. The loading force magnitude was set to 1200 N. The dynamic stress levels were observed using ten resistive strain gauges. The second tail boom bending mode is schematically shown in Figure 20.

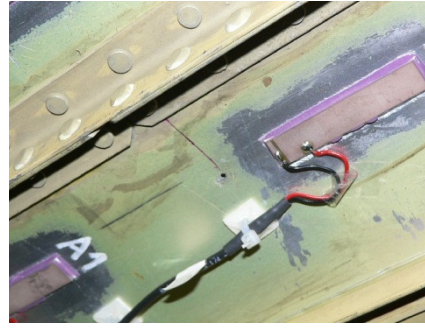
Figure 22 The fatigue crack from the cut #2 after 271600 cycles

During the loading three cracks were successfully initiated and grown. The largest crack propagated to the final size of 50 mm in 271600 cycles. Each 20000 cycles the testing was interrupted the zone was checked with eddy current NDE and the cracks were measured. Then the zone was monitored with experimental sensor array consequently generating ultrasonic waves with each sensor-actuator while the others were set to reception mode for ultrasonic wave sensing and recording with the oscilloscope.

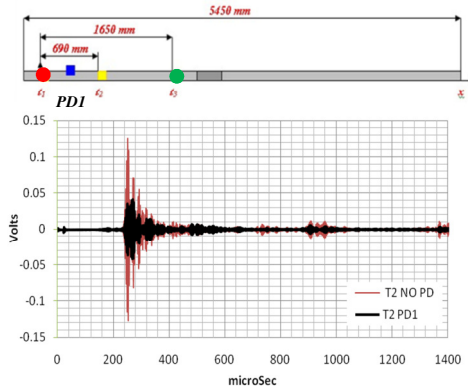
Figure 29 Pitch-catch waveforms received from sensor $T2$ (actuator $T1$). Intact condition (red) and pseudo defect $PD1$ present at $X=345$ mm (black)
