Application of Building Stone in the Old Kingdom of Ancient Egypt as an Indicator of Changes in Knowledge

Agnese Kukela¹, Valdis Seglins², ¹⁻²University of Latvia

Abstract. The study investigates the construction stages, materials and binder used in the Step Pyramid of Djoser to determine its current state of preservation. This research has allowed identifying 5 different building stone selection stages, marking the development of knowledge on construction materials and their properties. This pyramid is exposed to deterioration processes threatening stability of the structure. Unconsidered restoration strategy just aggravates the situation, but this study would assist in elaboration of appropriate conservation measures.

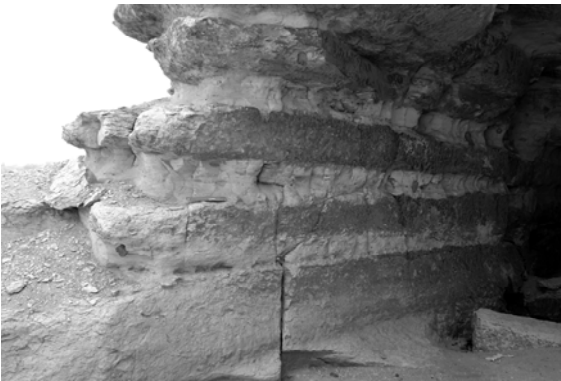
The Saqqara plateau is located in the seismically active area, where earthquakes with magnitude of about 4.0 happen yearly. As a result, massive limestone layers are cracked forming a peculiar structure of blocks measuring approximately 0.30 – 0.40 m (Fig. 1).

Fig. 1. Exposed fragment of geological section of Saqqara plateau

Larger intact natural limestone blocks are of rare occurrence. Seismic activities affect the monuments located on the plateau and result in loss of the stability of their structure.

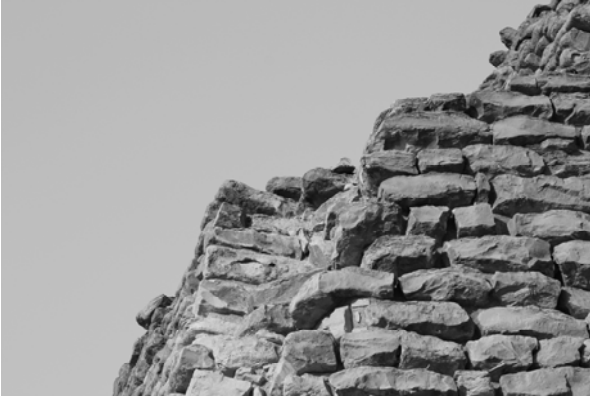
During this construction stage, at the lower part of the pyramid, while forming the first step, the quality of stone blocks is contrasting. At some areas these blocks are similar to those used during the previous construction stage (P1), yet the material of higher quality and of scrupulous choice is dominant. These blocks are tooled from all the sides. However, just on some of the images of photographic documentation there are visible traces of surface treatment. These are most characteristic features for the first two steps of the pyramid construction (Fig. 3).

Fig. 3. Characteristic quality of the blocks laid in the lower part of the Step Pyramid (southern façade).

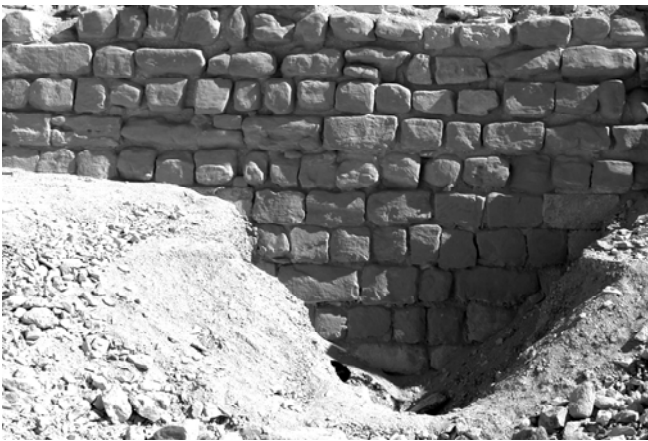
The building material used in the construction at the base of the western façade of the Step Pyramid requires special attention. Recently, the seventh or the lowest step of the pyramid was uncovered (Fig. 4). The existence of this step has been unknown until recent years, and there is no such step at least at the southern façade of the pyramid.

The stone material utilised in the construction of this base or "0" step is different. By its composition, this limestone is sandier than the one used further.

The stone blocks are tooled accurately, and surfaces are evened; the blocks are bond with little amount of adobe-gypsum mortar. Sizes of the blocks differ, and at least 3 types of sizes can be distinguished.

Fig. 4. Building blocks used at the base or "0" step at the western façade of the Step Pyramid

Unfortunately, it is impossible to detect the time period, when this masonry was laid and whether this really was a part of the step of the pyramid or just a support wall.

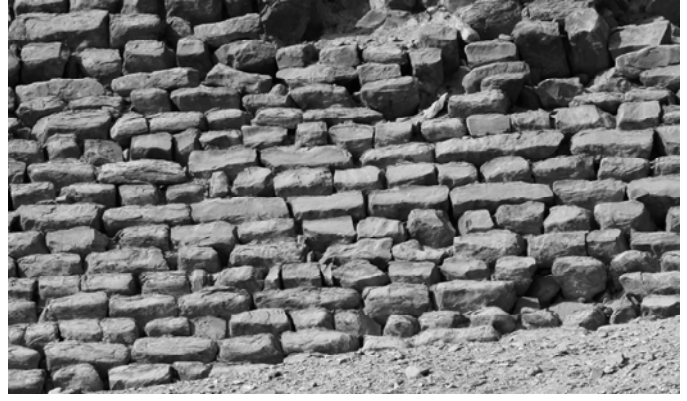
In the middle part of the Step Pyramid (mainly its third and fourth steps from below) the quality of building blocks is much higher (Fig. 5). These blocks are comparatively uniform, tooled, but with uneven surfaces (at this construction stage it is compensated with a large amount of adobe mortar). This building stage is rather contrasting – there are remarkable differences in amount of mortar applied to bond the building blocks and in the placement of the blocks and quality of such work. Most likely this denotes the existence of different teams of workers with different level of knowledge and qualification.

Fig. 5. Building blocks used in the fourth step of the construction of the Step Pyramid (southern façade)

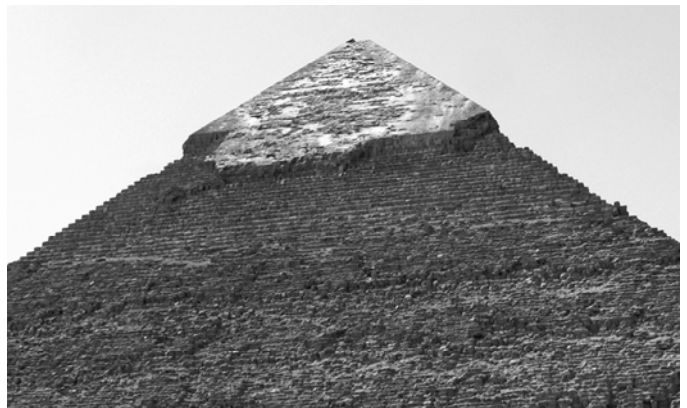
The lime-gypsum mortar binding these blocks most probably is the result of reconstructions. The composition of the stones is similar to the material used in the casing of other pyramids in the vicinity. Such limestone was also used in casing of the pyramids at Giza necropolis (Fig. 6).

Fig.6. The Pyramid of Khafre at Giza with the remains of casing from Tura-Maasara quarry
