**Edīte Biseniece**

# **SUSTAINABLE PRESERVATION OF HISTORIC BUILDINGS**

Summary of the Doctoral Thesis

RTU Press  
Riga 2021

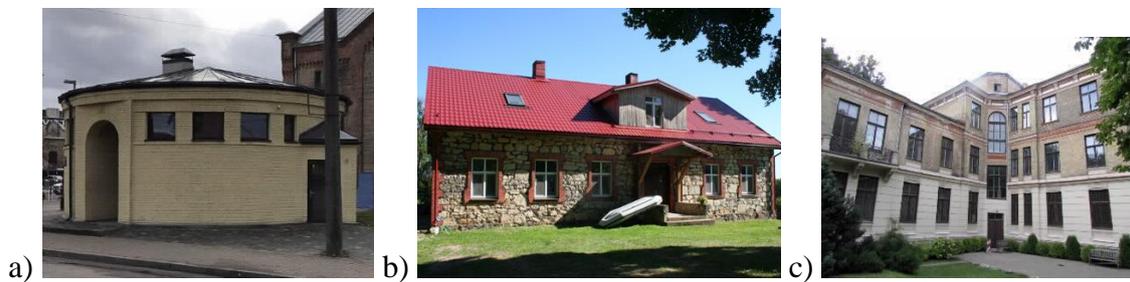
Fig. 1.1. a) Case building 1; b) Case building 2; c) Case building 3.

Three historic buildings (Fig. 1.1) were chosen as case buildings for this research. They differ by intended use, used construction materials and size. An overview of the buildings is given in Table 1.4.

Case buildings 1 and 2 had complete renovation with insulation of walls, roof, basement ceiling, change of windows and change of heating system. During this research, the owners of Case building 3 continuously postponed the completion of renovation work due to financial problems. At the time of research, internal insulation (50 mm mineral wool) on the above ground floors were installed, and the basement was insulated from the outside.

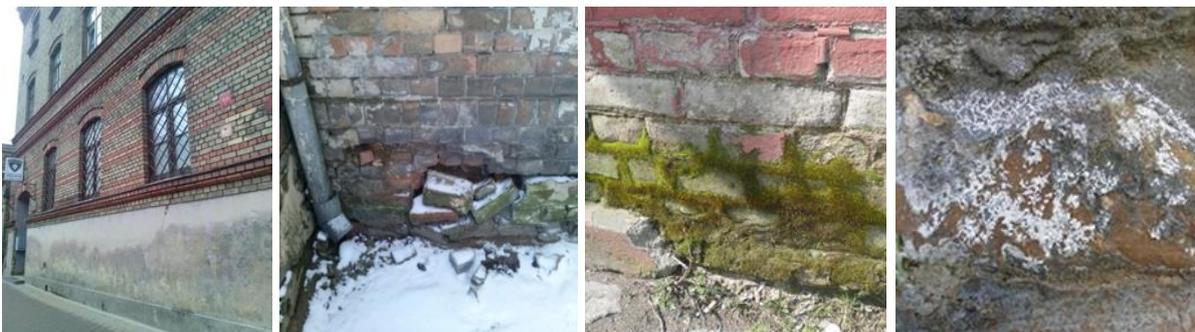
Fig. 2.2. Damages caused by moisture in masonry of historic buildings.

There is a statistically significant relation between building's technical assessment score. Using historical building pre-assessment tool, it is possible to identify the main problems and evaluate them. Primarily, buildings with higher specific energy consumption and higher technical assessment scorers should be renovated, as these buildings are in poor technical condition with a considerable potential to deteriorate even further, as well as by saving heat energy, it would be possible to make the renovation process more profitable. All inspected buildings have damages caused by moisture. Examples of damages that moisture causes are given in Fig. 2.2 and include damp rise, collapse of brickwork, algae growth, salt efflorescence.
