ANALYSIS OF FACTORS AFFECTING FRACTURES OF RAILS WELDED BY ALUMINO-THERMIC WELDING

D. Sergejev, S. Mikhaylov,
Riga Technical University, Riga, Latvia

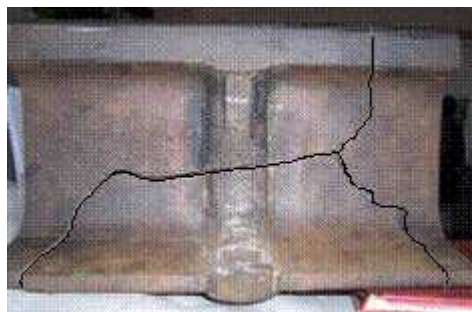
Experience of the operation of rails welded by the thermic welding showed that every year occur from 2 to 3 fractures of thermic joints on the main tracks between stations of Latvian Railway. In more cases these fractures of thermic joints are as shown in Figure 1.

Fig.1. View of a thermic weld fracture

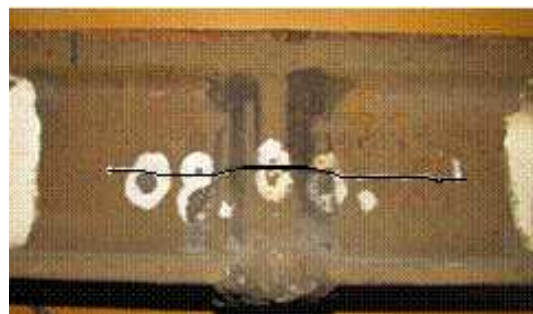
Fig.2. View of a thermic weld score and cracks revealed.

Rails for test were removed from the main railway network in service for more than 1 year. Continuous welded rails were welded using volumetric tempered rails P65 and UIC60 type with unhardened foot. All 6 rail joints welded by the thermic welding had through cracks of 200-300 mm of length on both sides of the weld joint alongside a score (see Fig.2). No load was applied to the rails with scores made on the lugs of the weld joint.

Such emergence of cracks in the weld joint alongside the scores indicates of great residual stresses in the weld joints made by the thermic welding.

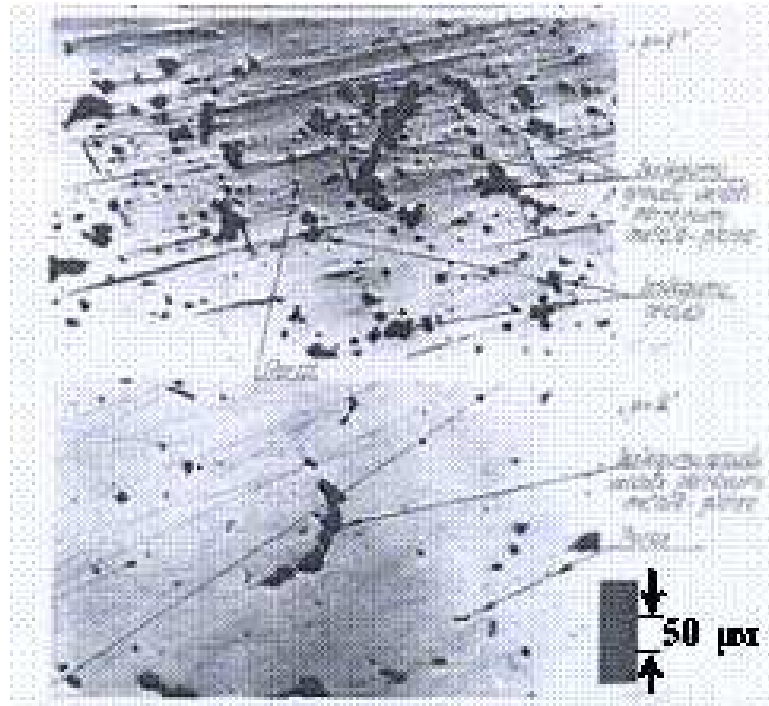
Fig.3. Structure of the thermic weld metal in the rail head.

The analysis of the metal structure in the thermic welded zone of rails showed that the weld metal had inclusions of iron oxides infused (FeO , Fe_2O_3 , and Fe_3O_4) and small pores (see Fig.3). The emergence of pores was caused by ingress of moisture into the thermite during the welding process on rails. Pores and infused oxides are concentrators of stresses and sources of cracks development. Pores and infused oxides reduce hardness of the weld joint under the action of tensile forces.

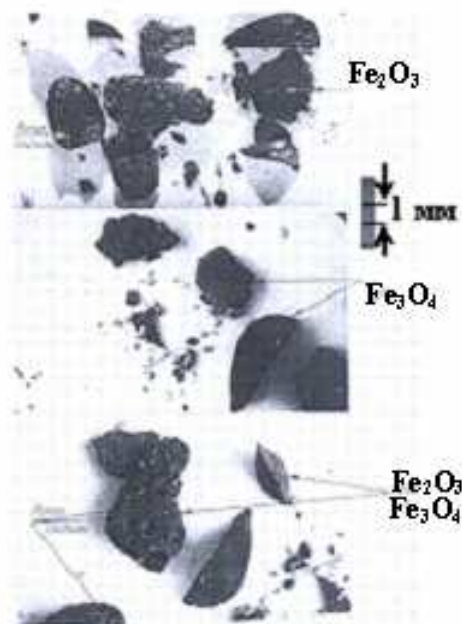
Fig.4. Structure of the thermite.

The analysis of the thermite structure showed that some elements of iron scale Fe_3O_4 and Fe_2O_3 have dimensions of 5-6 mm, while, according to the standard, their dimensions should not exceed 1-2 mm. Only at such conditions iron oxides have time to fuse at the temperature of $2600\text{ }^\circ\text{C}$. Just iron oxides remaining in the weld joint originate cracks formation in the weld metal and reduce its strength.
