Energetic Refurbishment of Historic Brick Buildings: Problems and Opportunities

Jurgis Zagorskas¹, Gražvydas Mykolas Paliulis², Marija Burinskienė³, Jūratė Venckauskaitė⁴, ¹⁻⁴*Vilnius Gediminas Technical University*, Torben Valdbjørn Rasmussen⁵, ⁵*Danish Building Research Institute, Aalborg University*

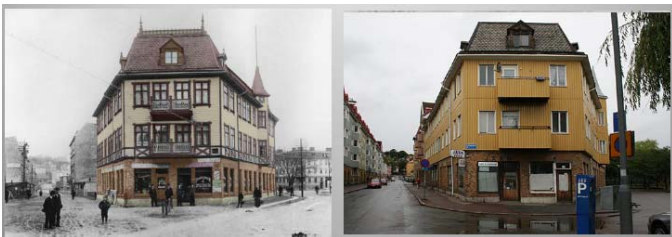
Fig. 3. Example of refurbished building when energy performance was increased to meet modern standards, but the authentic look of the building was destroyed.
