# Evaluation of Temperature and Humidity Regime in an Orthodox Church

Jekaterīna Nazarova<sup>1</sup>, Anatolijs Borodiņecs<sup>2</sup>, <sup>1-2</sup> *Riga Technical University*

**Abstract:** This study describes the cult buildings, properties and specifics of the cult building microclimate-related problems, based on the statutory requirements, also considering optimal parameters of the air. This study presents the results of indoor air monitoring in the cult building. The proposed methodology was evaluated in Riga All Saints Orthodox Church. During the evaluation, practical measurements of indoor air quality were taken. The recommendations for improvement of temperature/moisture conditions were presented.

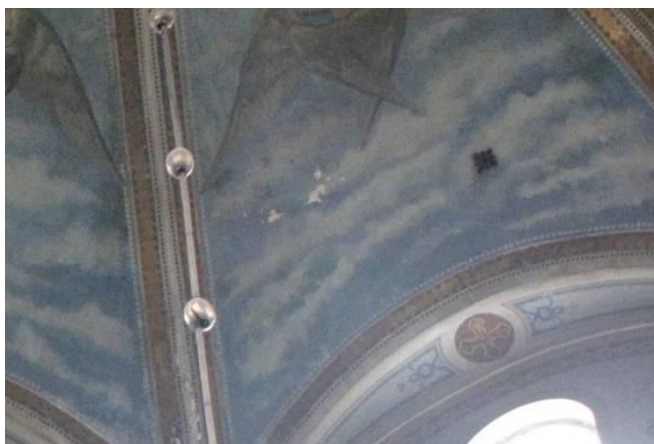
- Damages of dome inner surface (Fig. 1);
- Damages of the murals (Fig. 1);
- Appearance of the condensate on the inner building surfaces;
- Discomfort of the visitors and the clergy.

Fig. 1. Damages of dome inner surface and murals.

Corrosion of the inner surface of the cupola was found during inspections in the summer time. The appearance of corrosion is accompanied with increased humidity, which is caused by insufficient air exchange, it can also occur due to the lack of thermal isolation, which causes condensate formation on the surface. It is suggested that heat insulation is enhanced.

- The reason for condensate formation and consequent arch's inner surface corrosion could be the lack of thermal insulation. To prevent condensate formation, which is the primary reason for destruction of the paintings on the walls, it is necessary to improve the thermal insulation level of the cupola. This problem is common to the churches, which move from summer exploitation regime to the year-round regime.

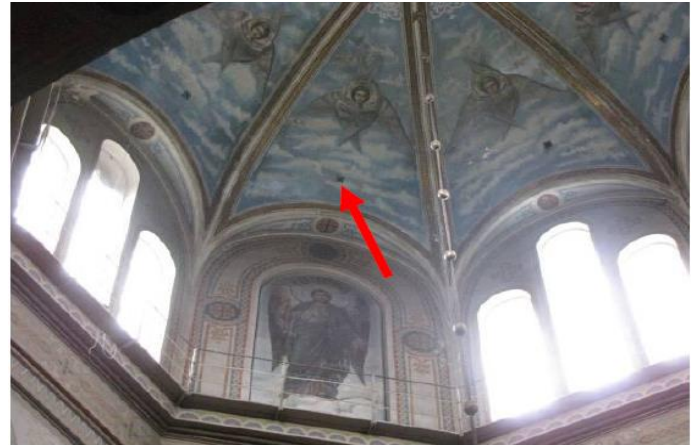
Fig. 2. Ventilation channels.

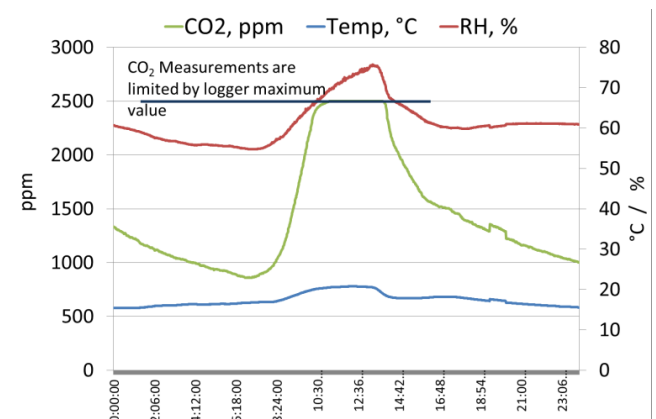
The overrun of the relative humidity upper limit was observed, which reached 75 % on 04 December, 2011, as well as overrun of the carbon dioxide concentration upper limit, which reached 3,300 ppm on 07 January, 2012

Temperature, relative humidity and  $\text{CO}_2$  measurement results, which are presented in the graph below (Fig. 3), show  $\text{CO}_2$  concentration reduction efficiency of the mechanical ventilation during the public worship time. The suggested solution to the problem is installation of a mechanical ventilation system with low noise level.

Fig. 3. Indoor air quality parameters during maximal occupancy on December 4, 2011.

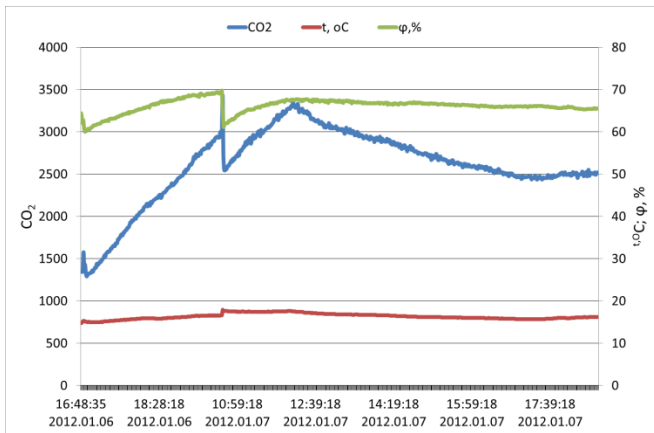
In order to get more precise data on CO<sub>2</sub> concentration, the loggers with higher maximum values were used during the period of celebration of the Orthodox Christmas in January 2012. Figure 4 shows indoor air quality during the Orthodox Christmas.

Fig. 4. Indoor air quality parameters on January 6–7, 2012.

As it can be seen, the CO<sub>2</sub> level reaches 3,500 ppm that is 3.5 times higher than the recommended values.

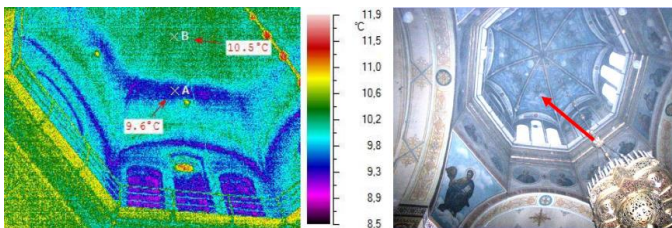
- Thermovision inspection of the cupola was carried out after heat insulation had been improved as suggested after the summertime period of research. The results have shown minor thermal bridge in the places, where arch is connected to the ceiling (Fig. 5). The reason behind the presence of the thermal bridges is insufficient insulation thickness across the ceiling and arch.
- Existing thermal bridges do not contribute towards condensate formation, but it is advisable to eliminate those during the thermal heating improvement works.

Fig. 5. Thermovision inspection of the cupola after heat insulation has been improved. Minor thermal bridge in the places, where the arch is connected to the ceiling.

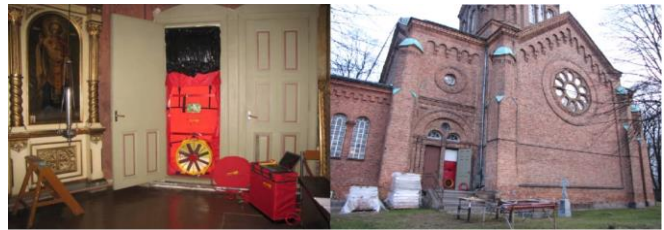
- Many defects of the structure were identified during the thermographic analysis using pressure distance forming tool (Fig. 6), i.e. air exfiltration and infiltration places as well as spots of increased humidity levels (Fig. 7).

Fig. 6. BlowerDoor pressure distance forming tool.

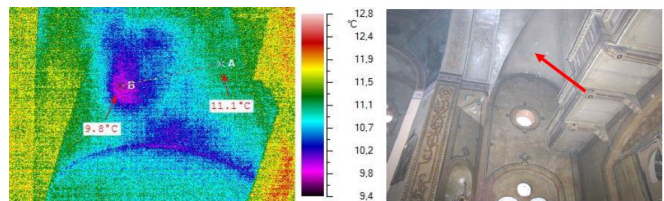
- Repeated thermographical analysis of the inner part of the church confirmed the presence of defects discovered during the summer research. These were caused by

increased humidity levels in the ceiling and abnormal infiltration and exfiltration of the air through the window and door frames, as well as the points of contact of the walls with the floor.

Fig. 7. Spots of increased humidity levels.

- It is recommended to remove the air infiltration through the door and windows as well as to conduct a study to determine the reasons of the temperature anomalies in the northern and southern walls of the cathedral as well as in the altar arches and to find out the moisture ingress ways into the structure.
