Service Life of Two 100 Year Old Concrete Bridges in Latvia

Kristaps Gode, *Riga Technical University*, Ainars Paeglitis, *Riga Technical University*

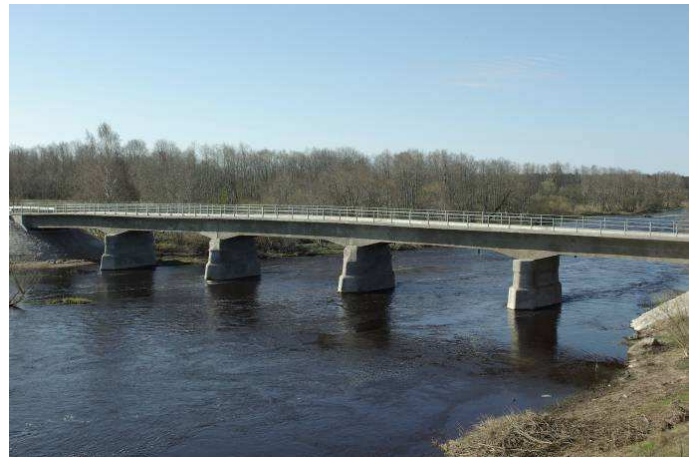
Fig.1. The bridge over Salaca river, built in 1908

Bridge over river Salaca near city Salacgriva is currently the oldest reinforced concrete bridge in Latvia (fig.1). The bridge was built without a contract and was financed by knighthood of Vidzeme in 1908.

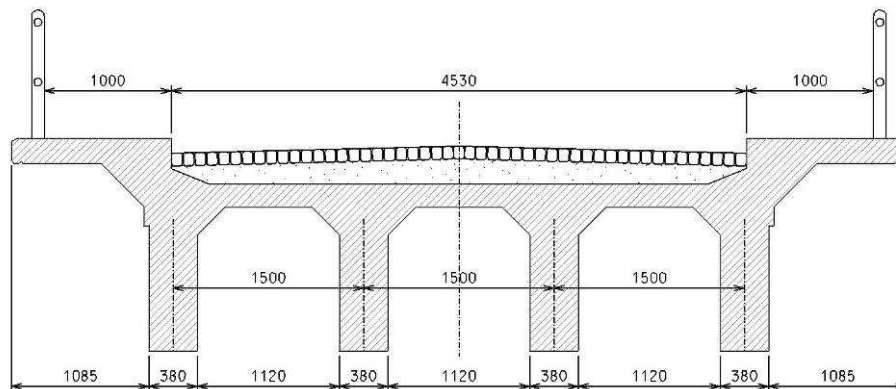
Fig.3. The cross section of the bridge over river Gauja

At the time most of the concrete structures were build by French and German companies which did not want to share with their designing and building secrets [7]. The bridge has five spans and consist two continuous (17.90m + 17.90m) two span beams at sides and one span beam in the middle (18.15m). The cross sections of the both bridges are the same – there are four monolithic beams (fig.3). The beam height at

piers is 2.04m, in the middle of span – 1.44m. In 1944 the both end spans were blown up. After the WWII the spans were repaired in timber, but in 1962 both spans and side piers were renovated in the original concrete design [7]. In the 1992 the bridge load test showed very good results. In 2007 the bridge surface was repaired with shotcrete. The bridge over river Gauja at city Strenci was built in the same way as the bridge over Salaca (fig.2.). Bridge was completed in 1909. Initially it was a four span bridge the same design as bridge over Salaca, consisted of two continuous two span beams. In 1919 during the war time, the first span was blown up. It was repaired in 1921, the design project of repair can be found in archives [8]. In 1929 flooding of river Gauja and ice forging destroyed the bank at the side of Strenci city [7]. During the depression years additional two spans were built in welded steel beam and timber deck design. The timber deck since then has been rebuilt couple times. This is the current state of the bridge.
