## ANALYSIS OF QUALITY CONTROL PLANS FOR BRIDGE OVER THE RIVER MAZA JUGLA ACCORING TO COST TU 1406 METHODOLOGY

Roberts Auzins<sup>1</sup>, Ainars Paeglitis<sup>1</sup>

<sup>1</sup>*Department of Roads and Bridges, Civil Engineering Faculty, Riga Technical University, Riga, Latvia*

This article analyses and compares different Quality Control Plans developed according to COST TU 1406 methodology for the existing bridge over the river Maza Jugla, located on regional road P10 at km 34.80 in Latvia.

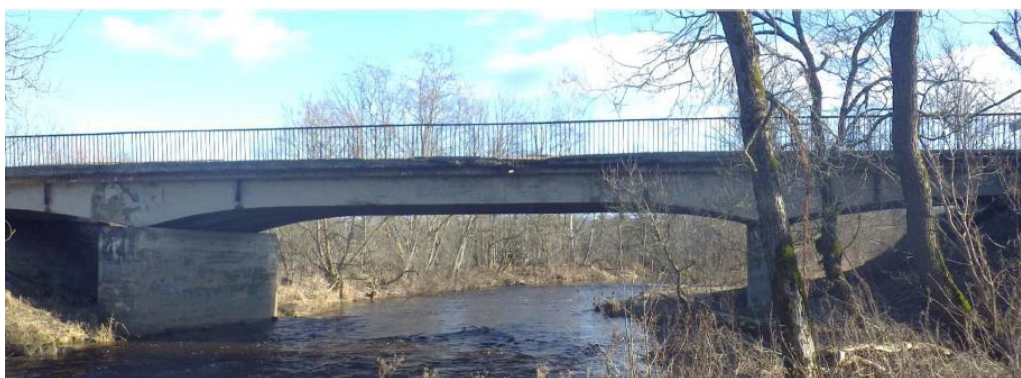
Figure 2. Bridge overview

The bridge over the river Maza Jugla is located in the Latvian regional road network on regional road P10 Incukalna-Ropazi-Ikskile at kilometre 34.80 (see Figure 1 and Figure 2). As the bridge is located in the urban area Tinuzi, the allowed driving speed is 50 km/h. According to last traffic data from 2019 the traffic intensity is 1677 cars per day including 11% of heavy traffic. According to data of Latvian bridge management system LatBrutus the bridge condition is evaluated as “Very poor condition”.

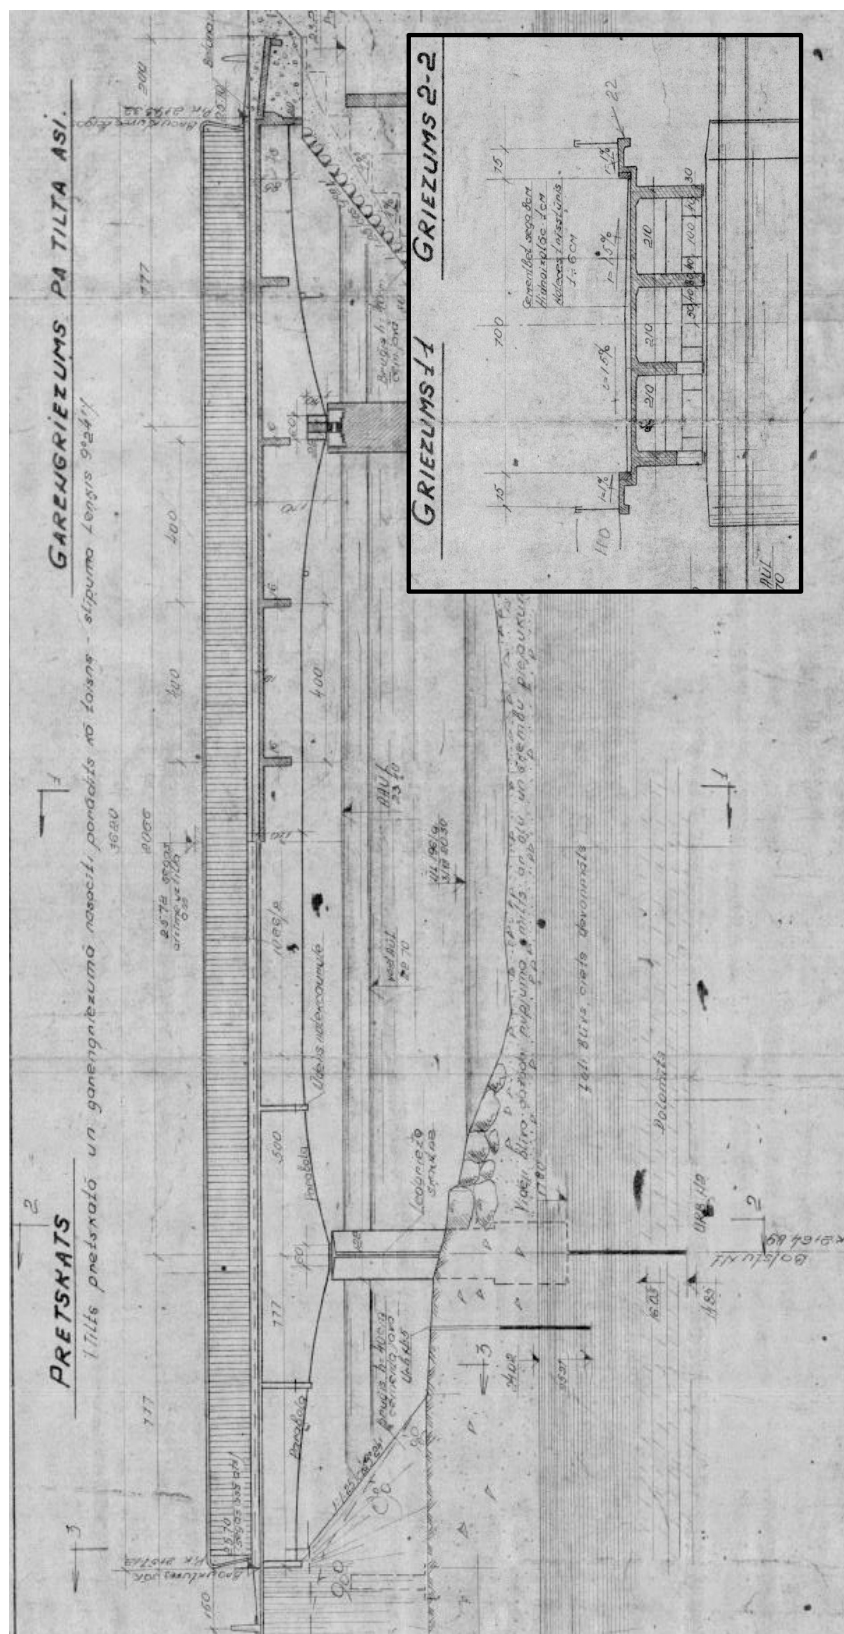
Figure 3. Original drawing of bridge over the river Maza Jugla

New bridge superstructure over the river Maza Jugla was built in 1962 on the existing cast-in-situ reinforced concrete abutments built in 1948. Bridge superstructure is made of four continuous reinforced concrete cast-in-situ cantilever beams with scheme  $7.65+20.30+7.65\text{m}$ . Main beams are connected with cast-in-situ cross beams. The bridge is designed according to Soviet traffic loads N-13 and special vehicle loads NG-60. The original bridge design documentation is shown in Figure 3. In cross section the superstructure has two pedestrian sidewalks with corresponding width of 0.85m and carriageway with the total width of two lanes of 7.0 m.
