EXPERIMENTAL EVALUATION OF DAMAGE INFLUENCE ON BUCKLING PERFORMANCE OF STIFFENED CFRP SHELLS

O. Ozoliņš, K. Dzelzītis, E. Eglītis

Keywords: buckling, post-buckling, delamination, non-destructive inspections

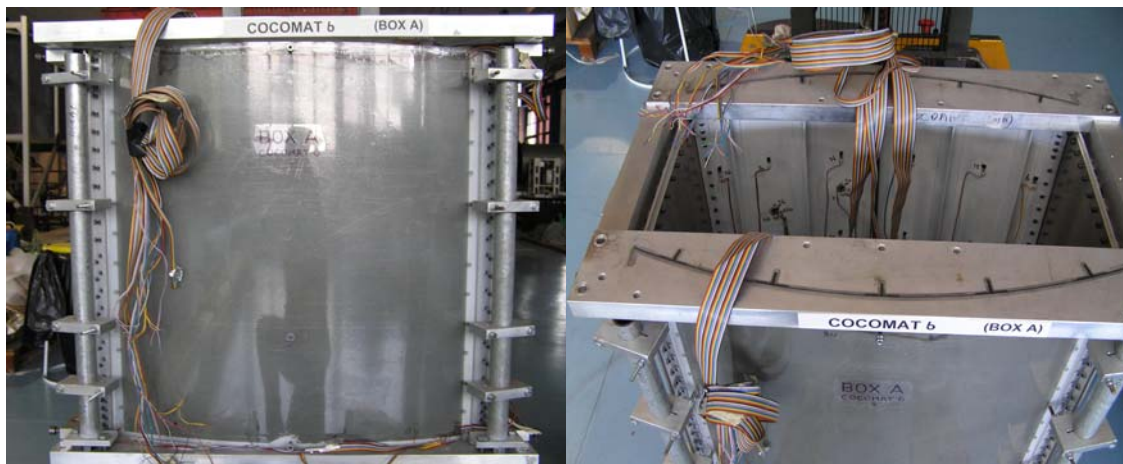
Fig. 1

COCOMAT torsion box consisting of two face stiffened panels, connected by two flat side panels.

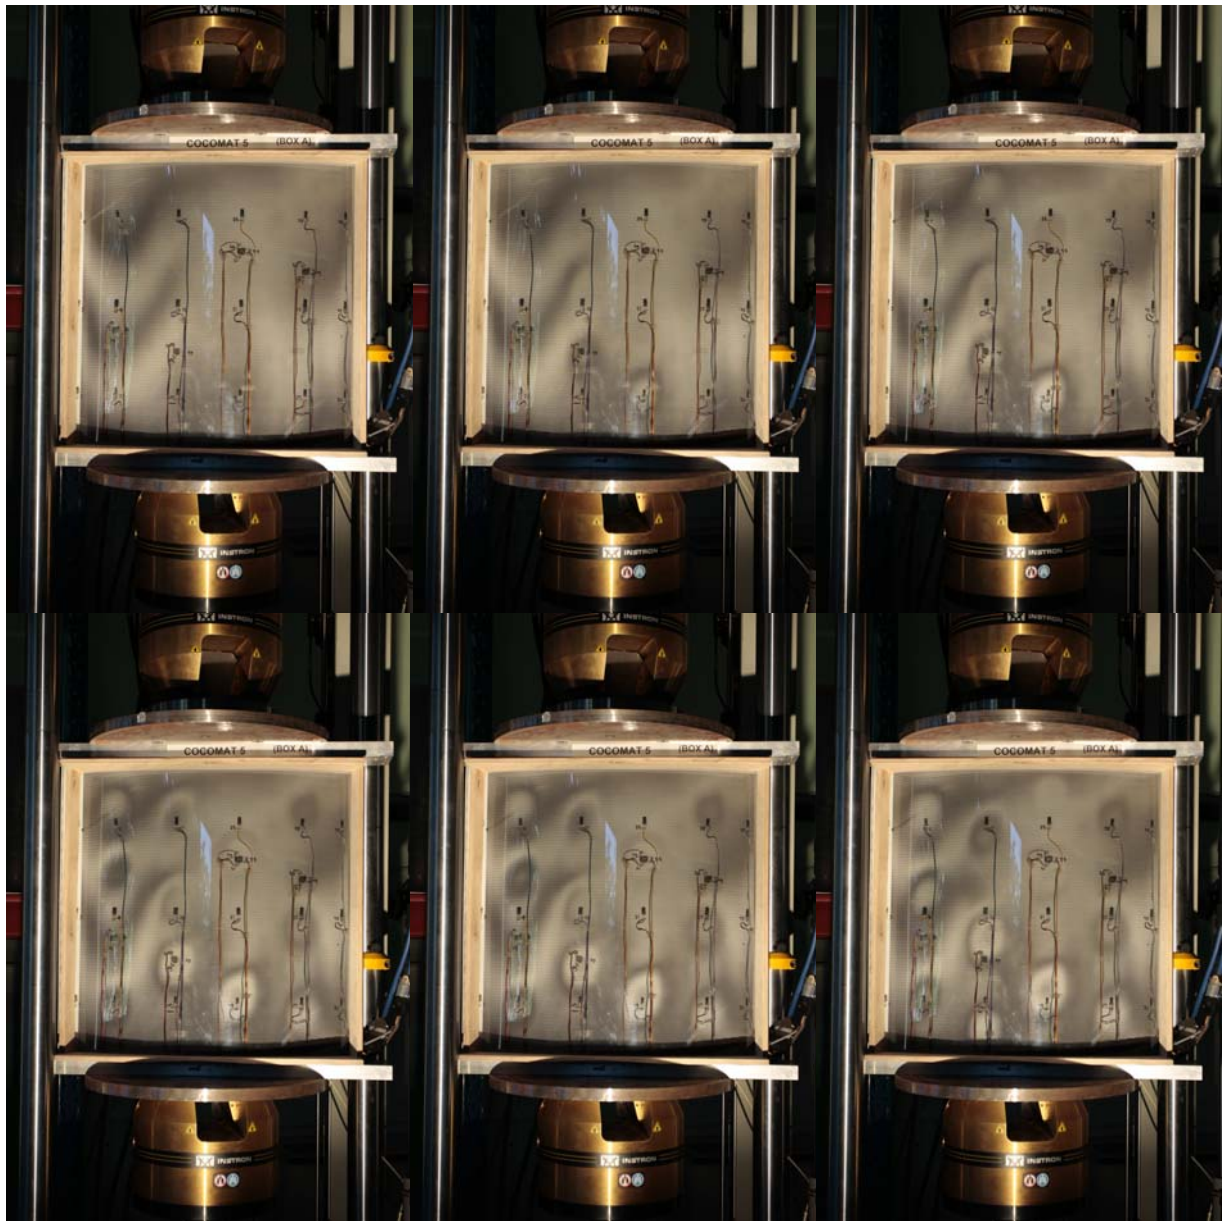
Fig. 10
Evolution of buckling and postbuckling mode shapes for non-damaged panel

As seen in Fig. 8, the panel without damage (a) has more regular buckling mode shape pattern than the one with stiffener delaminations (b). This indicates that the load distributes less uniformly across the panel width in the damaged specimen, thus resulting in stress concentrations, which can lead to further delamination growth or material failure. Stress misbalance can considerably decrease the load carrying capacity of the panel, especially in the post-buckling region.

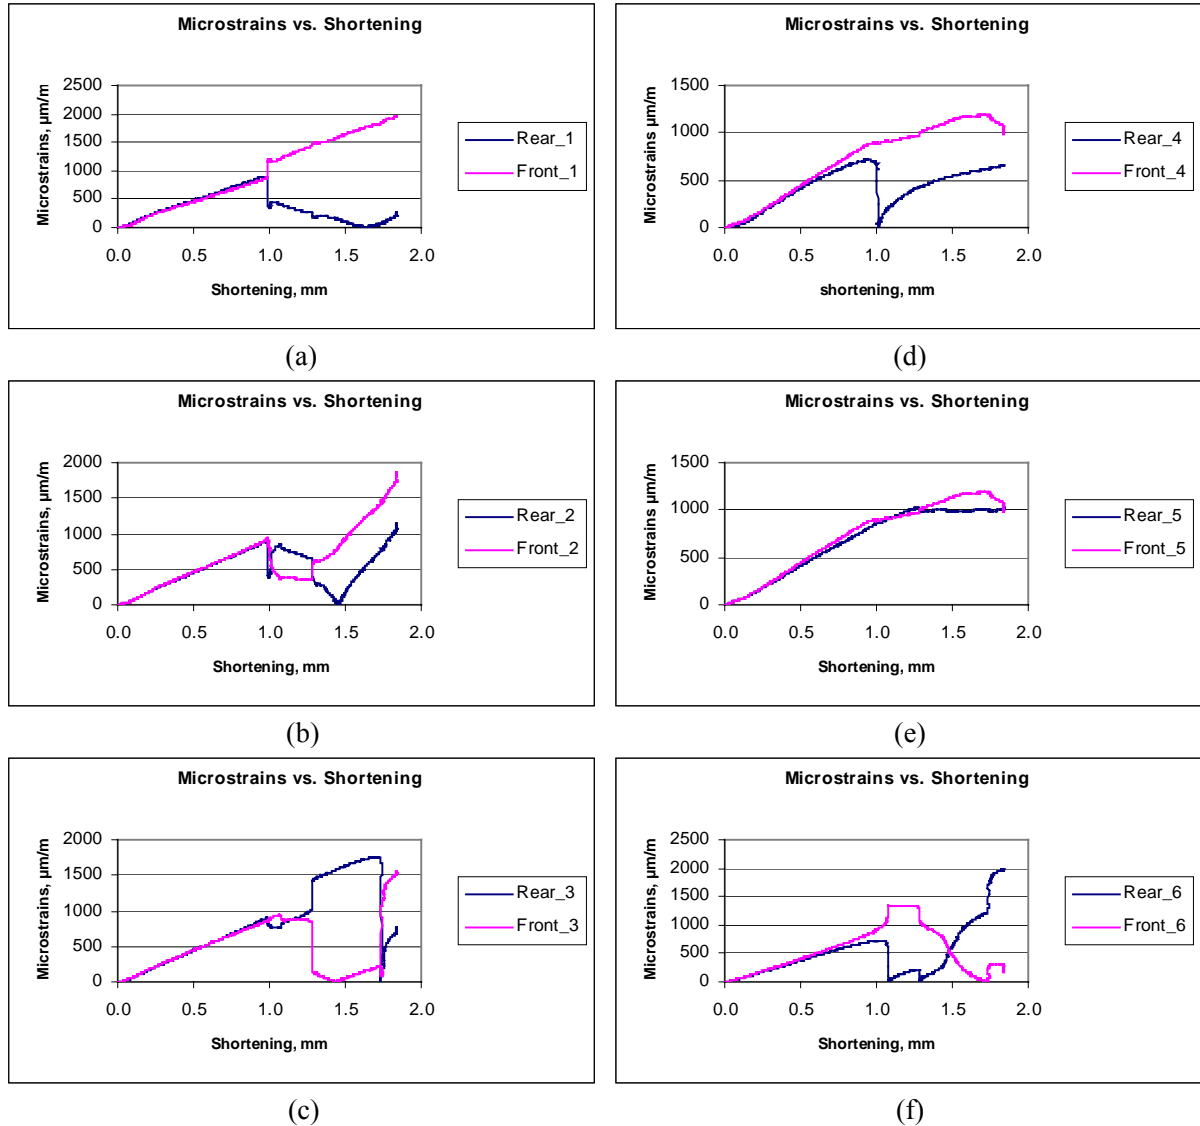
Fig. 13

Strain gauge measurements in RTU tests of COCOMAT 5 (BOXA) non-damaged panel

Despite the decrease in the stiffness characteristics of the structure for the damaged specimen, the buckling occurs at almost identical strain level for both panels, which stays the same through the whole loading range. At the maximum load, the strains recorded by the strain gauges are 6% lower in the damaged panel than they are in the undamaged one. This can be partly explained by different locations of the strain gauges on the specimens, as explained in the chapter 4.1.
