## STRENGTH OF FIBROUS COMPOSITES WITH IMPACT DAMAGE

*Igor Pavelko<sup>1</sup>, Vitalijs Pavelko<sup>1</sup>, Rafal Chatyś<sup>2</sup>*

<sup>1</sup> *Aviation institute of RIGA Technical University, Riga, Latvia*

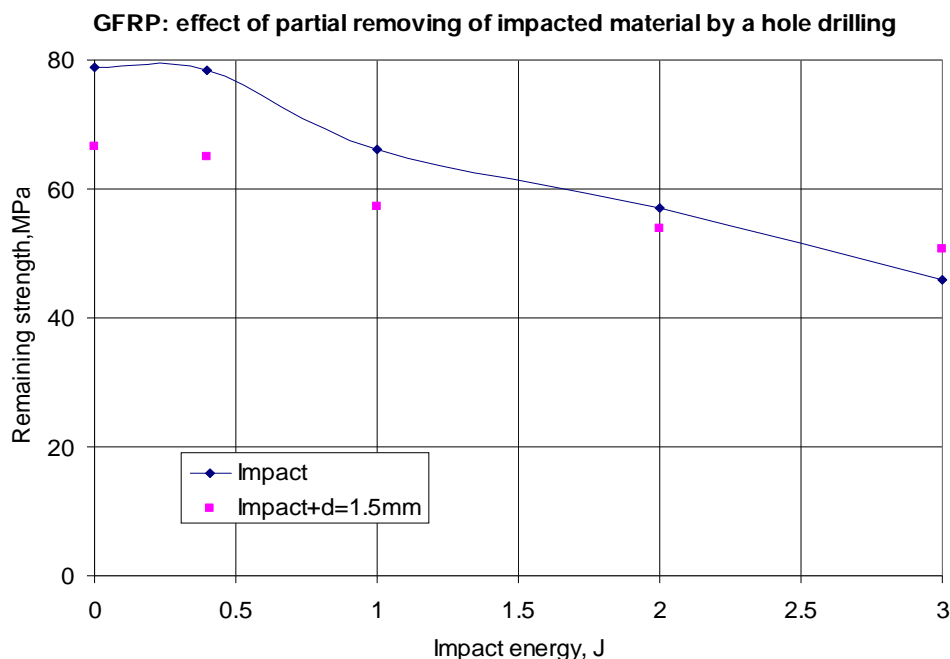
*Figure 1. Remaining strength of GFRP for two kinds of samples: 1) impacted and 2) impacted sample with 1.5 mm hole in center of damaged zone*

The analysis of the stress state in a zone of impact allows obtaining some qualitative judgments and quantitative estimations of character and the sizes of a zone of impact damage. Different criterions of the stress state as a cause of destruction at impact were used. That analysis can give the sufficient information for the approximate prediction of kind of partial destructions in a material and the sizes of a zone of damage. Research and use of knowledge of the phenomenon of self-supported destruction of the brittle components of a composite is especially perspective. On the one hand this mechanism is one of the most damaging, and with another, for its studying criteria of linear fracture mechanics can be effectively used. It is very important also the experimental result that illustrates existence of an equivalent hole for composites with brittle components.
