ANALYSIS OF DECK SLAB OF REINFORCED CONCRETE GERBER-GIRDER BRIDGE WIDENED BY ADDITION OF CONTINUOUS STEEL-CONCRETE COMPOSITE GIRDERS

WOJCIECH SIEKIERSKI*

*Dept of Bridges, Faculty of Civil and Environmental Engineering,
Poznan University of Technology, Poznan, Poland*

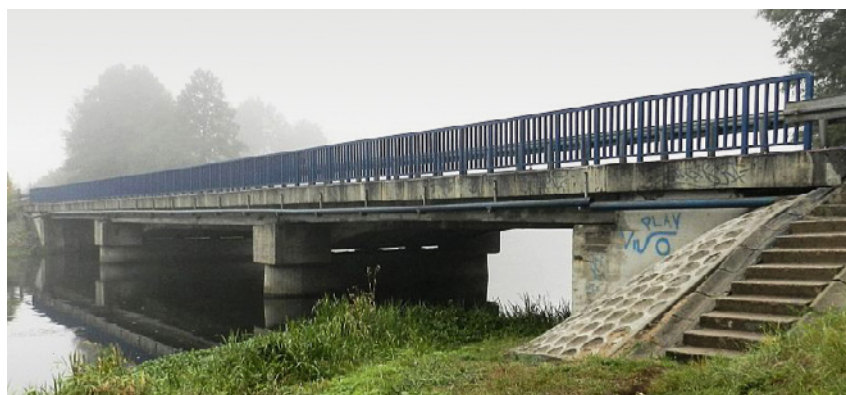
Figure 1. General view of the analysed bridge (photo A. Madaj)

The principle above was neglected in the case of the bridge shown in Figure 1. Its cross-section, static scheme and elevation are shown in Figure 2. Each of the outer spans consists of the cantilever (length – 5.5 m) and supported span (length – 9.0 m). The Reinforced Concrete

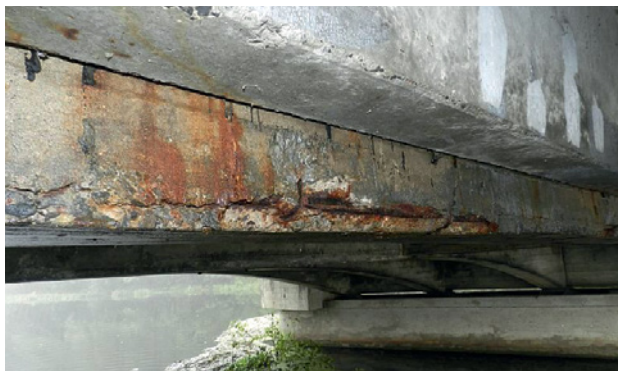
Note: concrete and reinforcement corrosion of the outermost RC girder.

Figure 3. The initially outermost Reinforced Concrete girder covered by the added I-girder (photo A. Madaj)

Due to variations in deflection lines of the outermost RC girders and the added prestressed girders, the longitudinal joint of the existing structure and the added girders lost its water tightness (Madaj, Mossor, & Siekierski, 2017). The outermost RC girders experienced extensive damage (Figure 3) caused by leaks of water containing chlorides (Gode & Paeglitis, 2014). Due to the close vicinity of the added Π -girders, the damaged regions of the outermost RC girders are hard to access and thus hard to repair.
